# Inspection Report

**Safehome PTY LTD**

**1 Smith St, Pennydale, VIC, 3192**

Report/Agreement #	2305230921506
Inspection Date:	23 May 2023
Inspection Time:	11:00 am

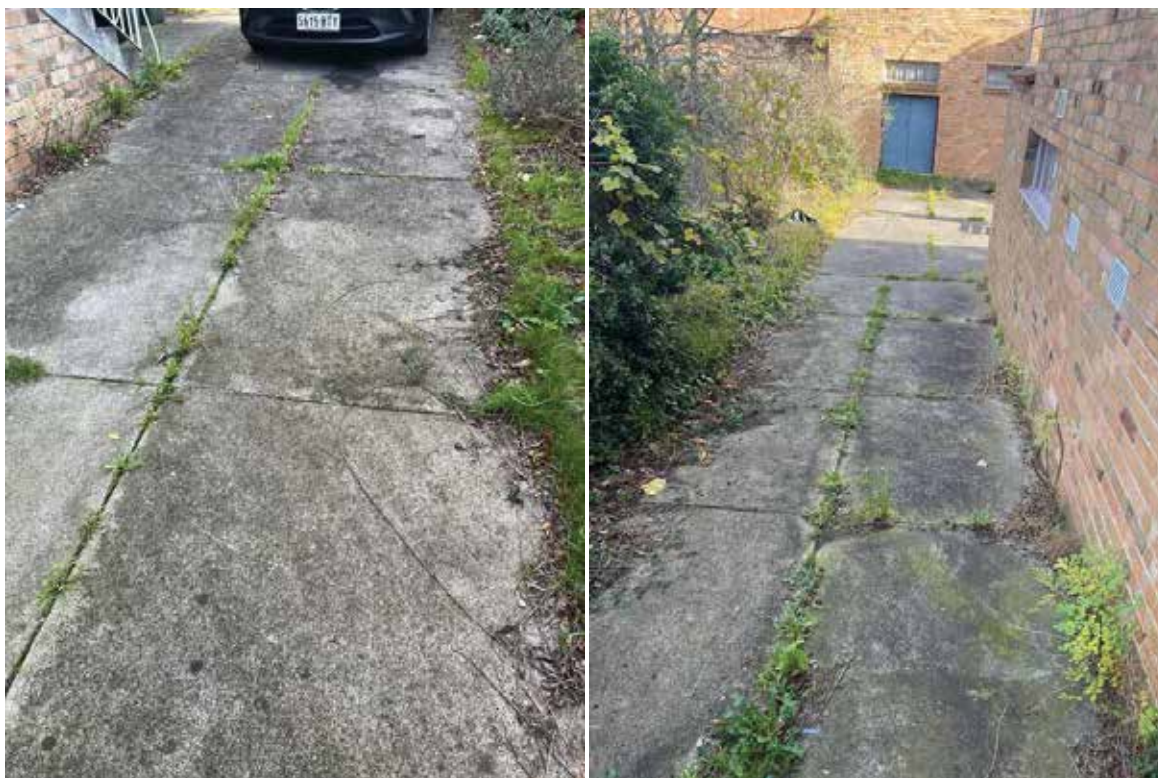
Driveway has visible tripping hazards in sections. Repairs are required by a qualified concreter to avoid potential injury.

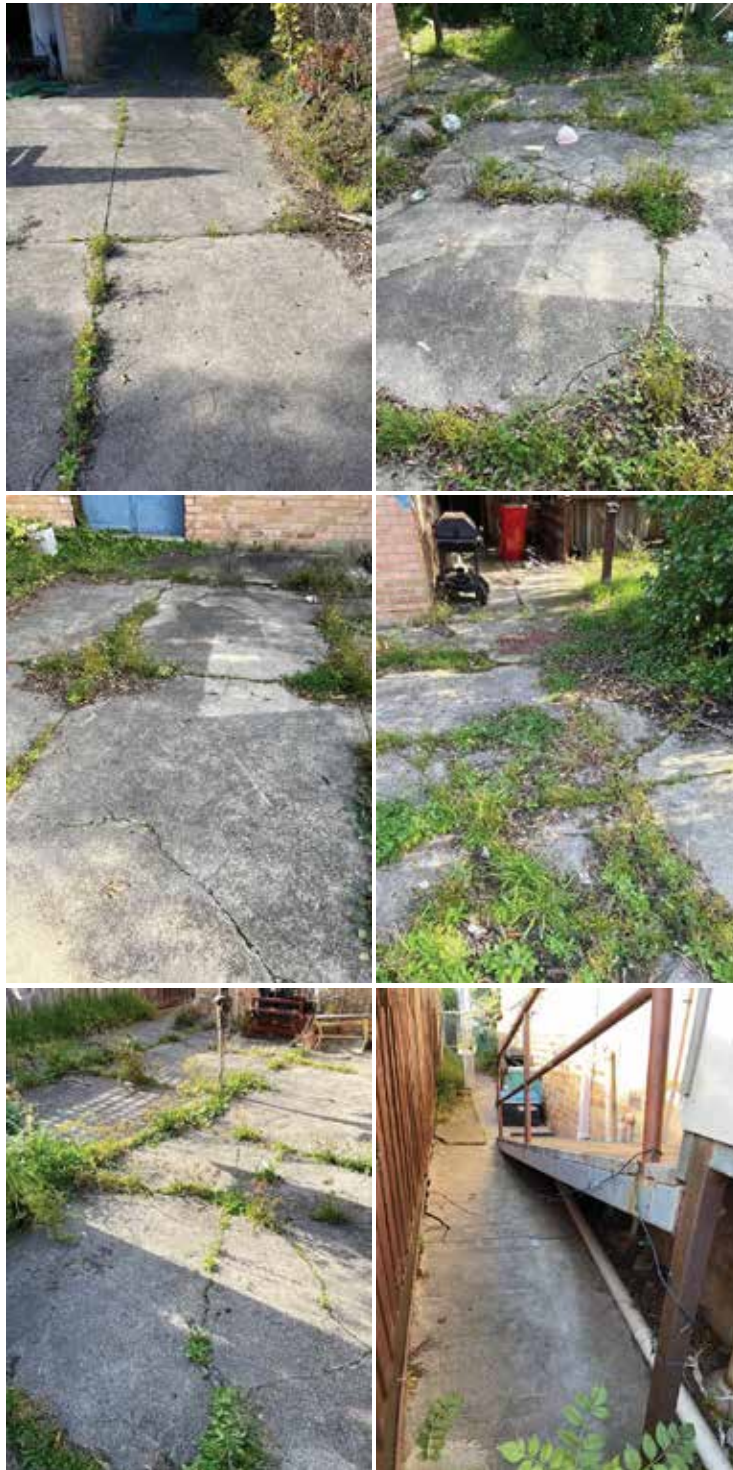
The driveway is in poor condition & replacement by concreter recommended.

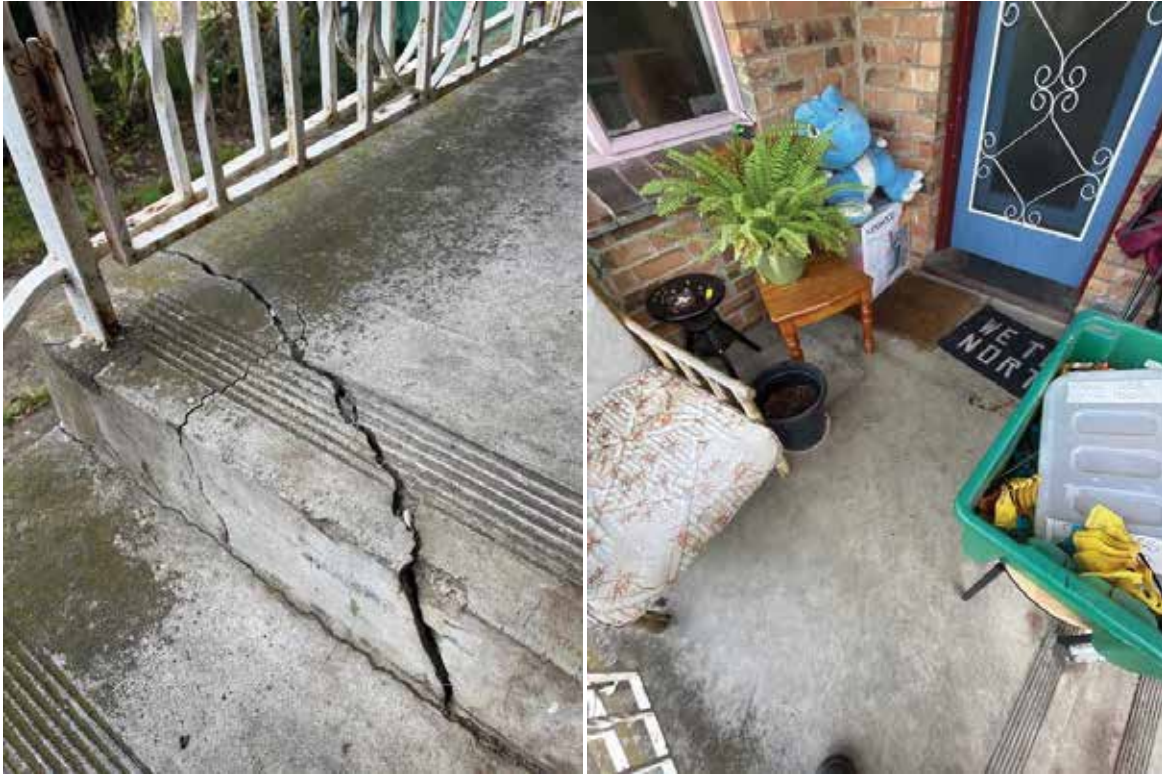
The entry area concrete slab has subsided/dropped/large cracks. This is often observed in older homes due to poor footing construction - Engage a qualified concreter to assess/repair.

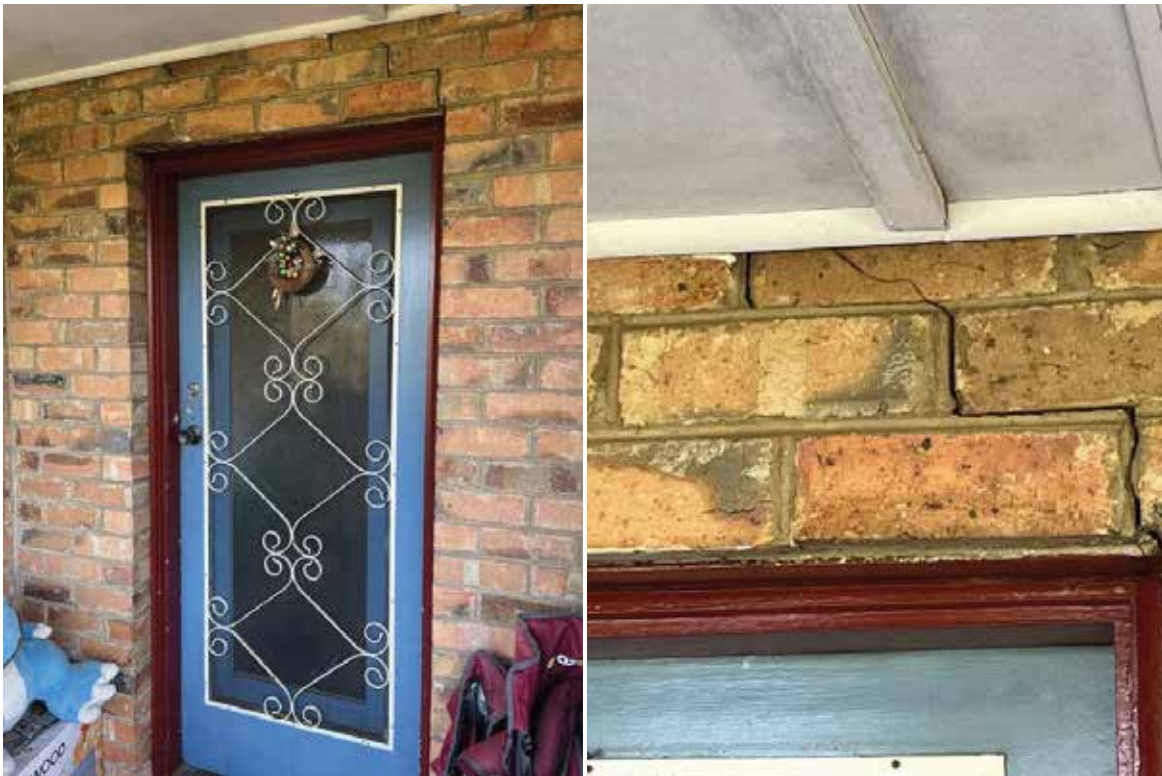
General age deterioration and wear to areas - General maintenance / upkeep to areas required.

Settlement cracks in areas. Monitoring for 12 months advised & if widening subsequently occurs it will require assessing by a structural engineer or brick layer.

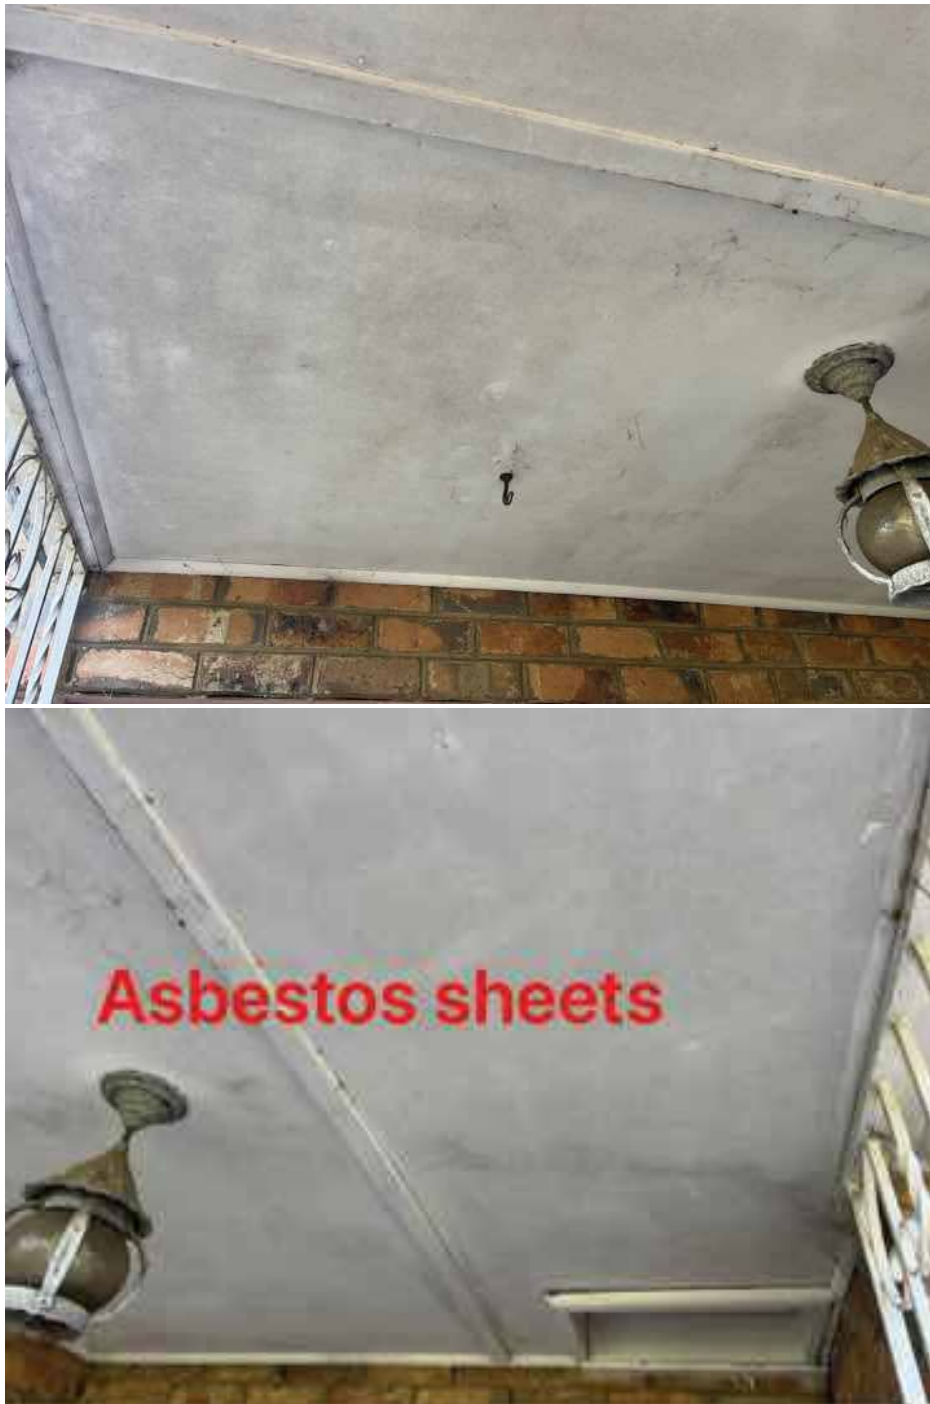
Ceiling stains - Appear to have emanated from Roof Area. No moisture readings obtained from same. These may have been repaired, however a qualified plasterer should be engaged for advice and recommendations and to assess damage to plaster and inaccessible framing.

Paint on lining has deteriorated in areas. Have prepped and painted.

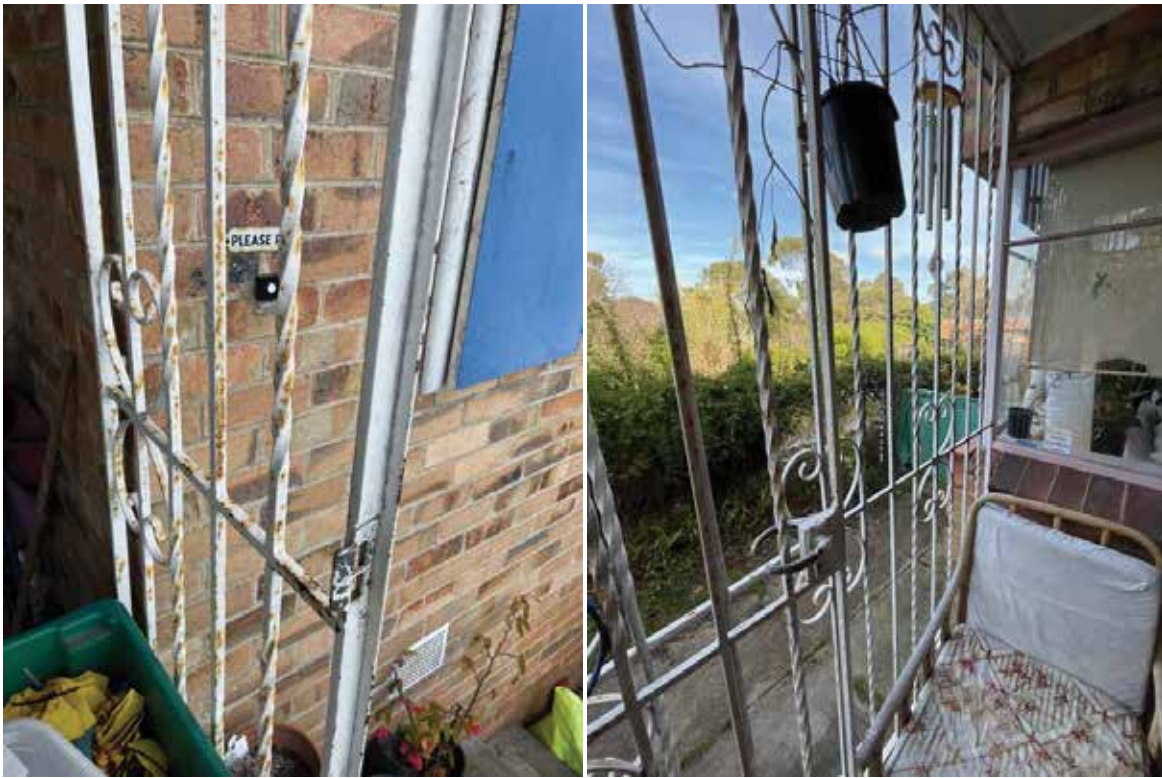
Rust deterioration evident on sections of posts/components - Engage a qualified trades person to assess with view of restricting / repairing the rust.

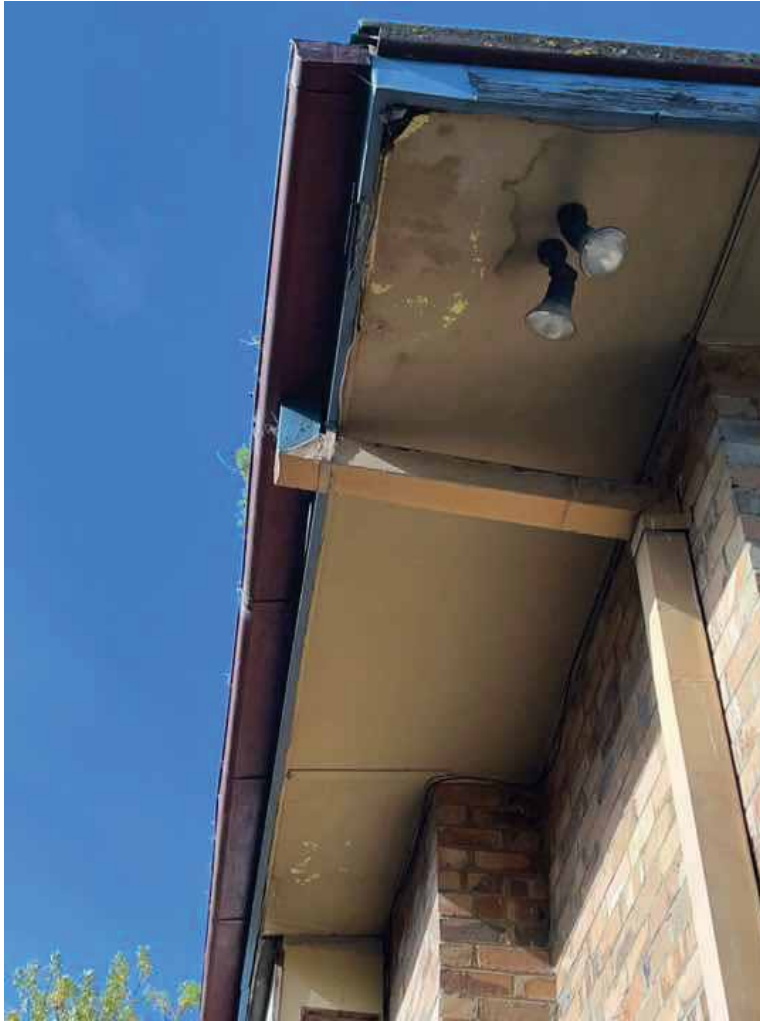
Gutter surface rust in sections - replacement recommended in near future.

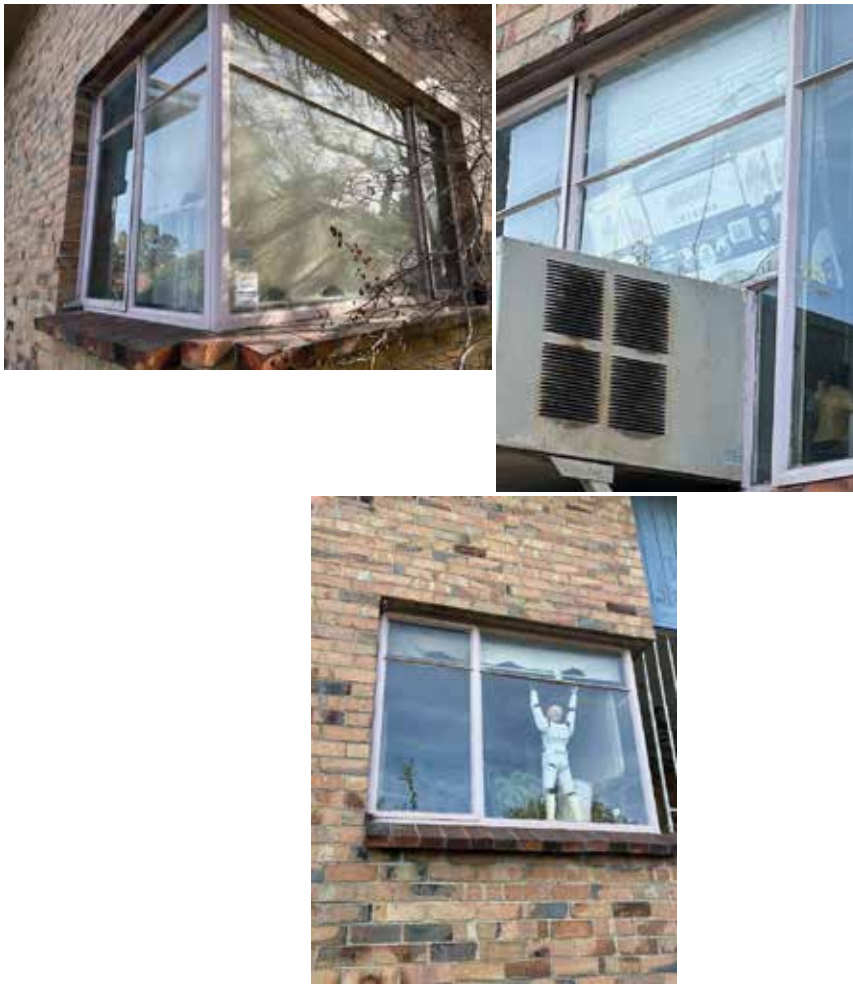
Rust is evident in sections of the homes window framework. Some areas should be repaired. A qualified carpenter should be engaged for advice & recommendations regarding restriction of rust.

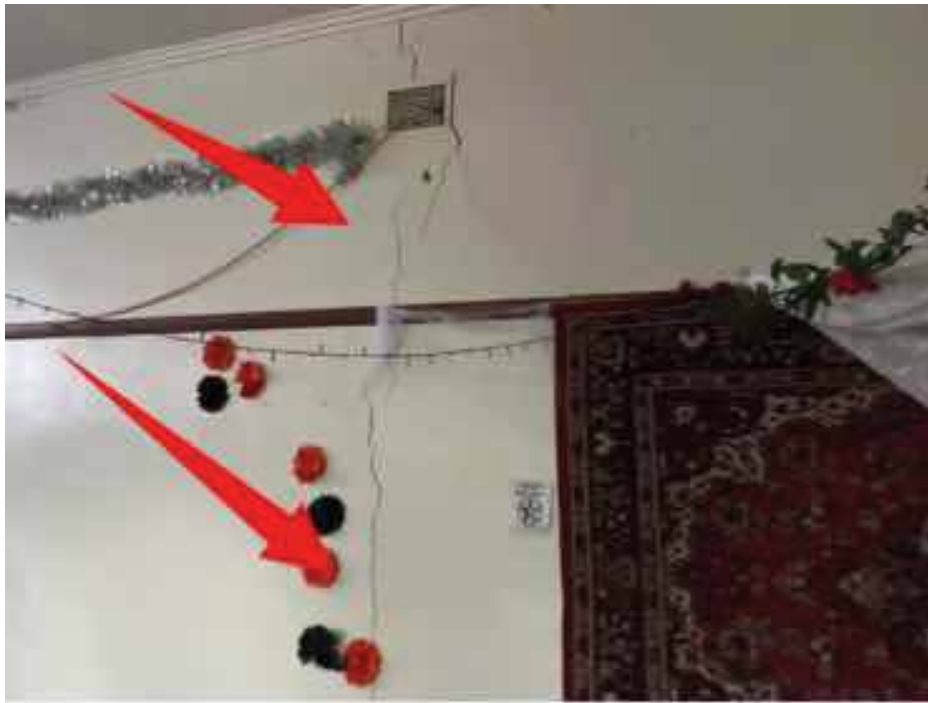
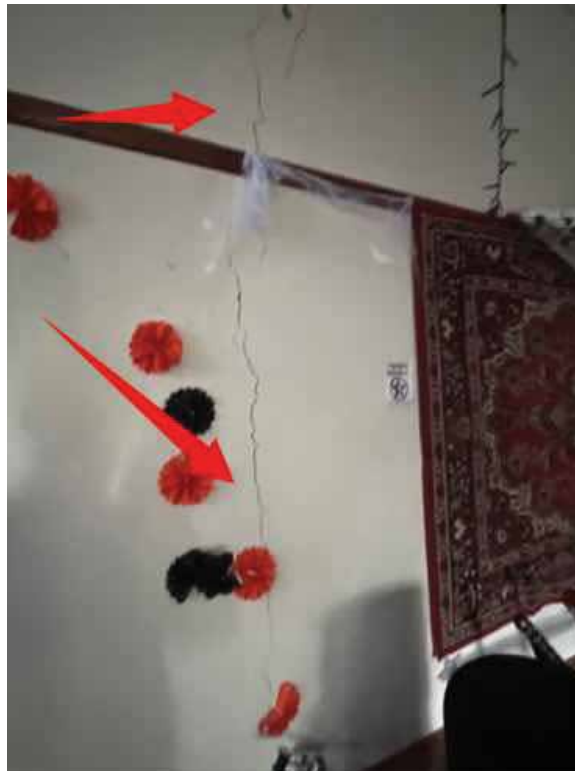
Old damp damage to wall. Tested and dry today. Repairs by a plasterer recommended.

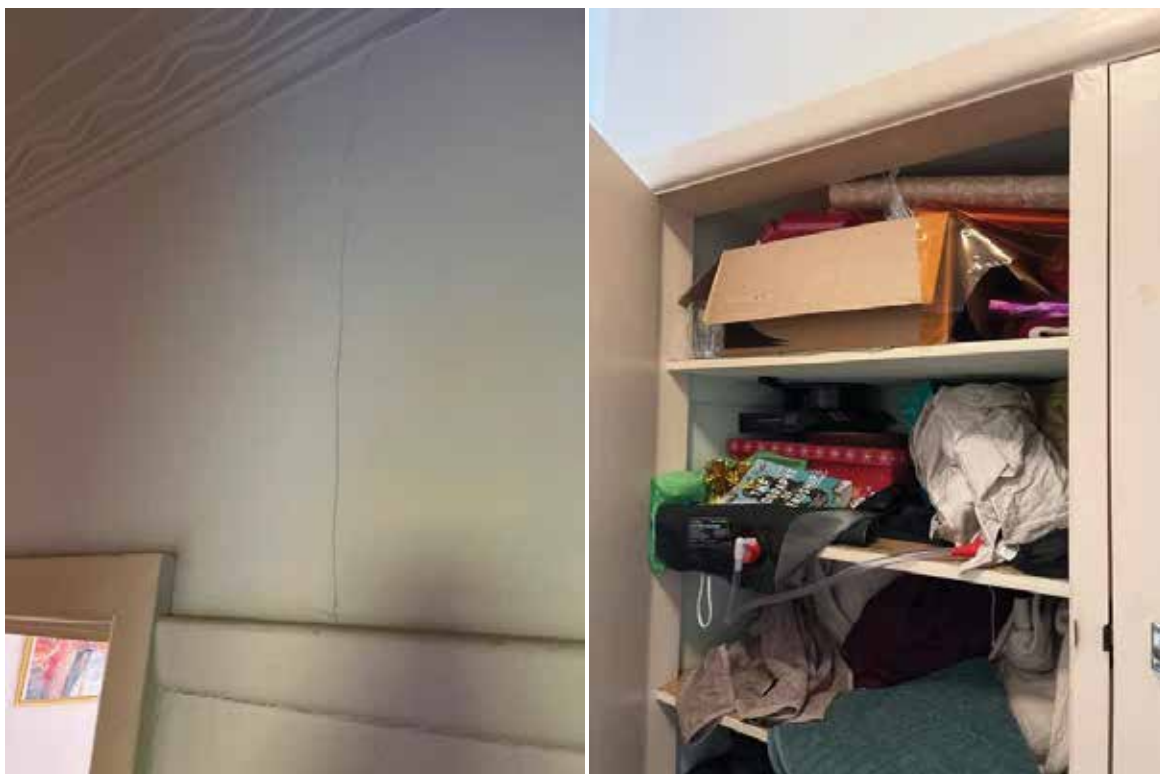
Settlement Cracks on wall areas. This can be related to differential settlement in footings, shrinkage in timber framing or poor plastering. Monitoring these cracks for 12 months is advised & if become wider or longer, you will need to contact a structural engineer to assess.

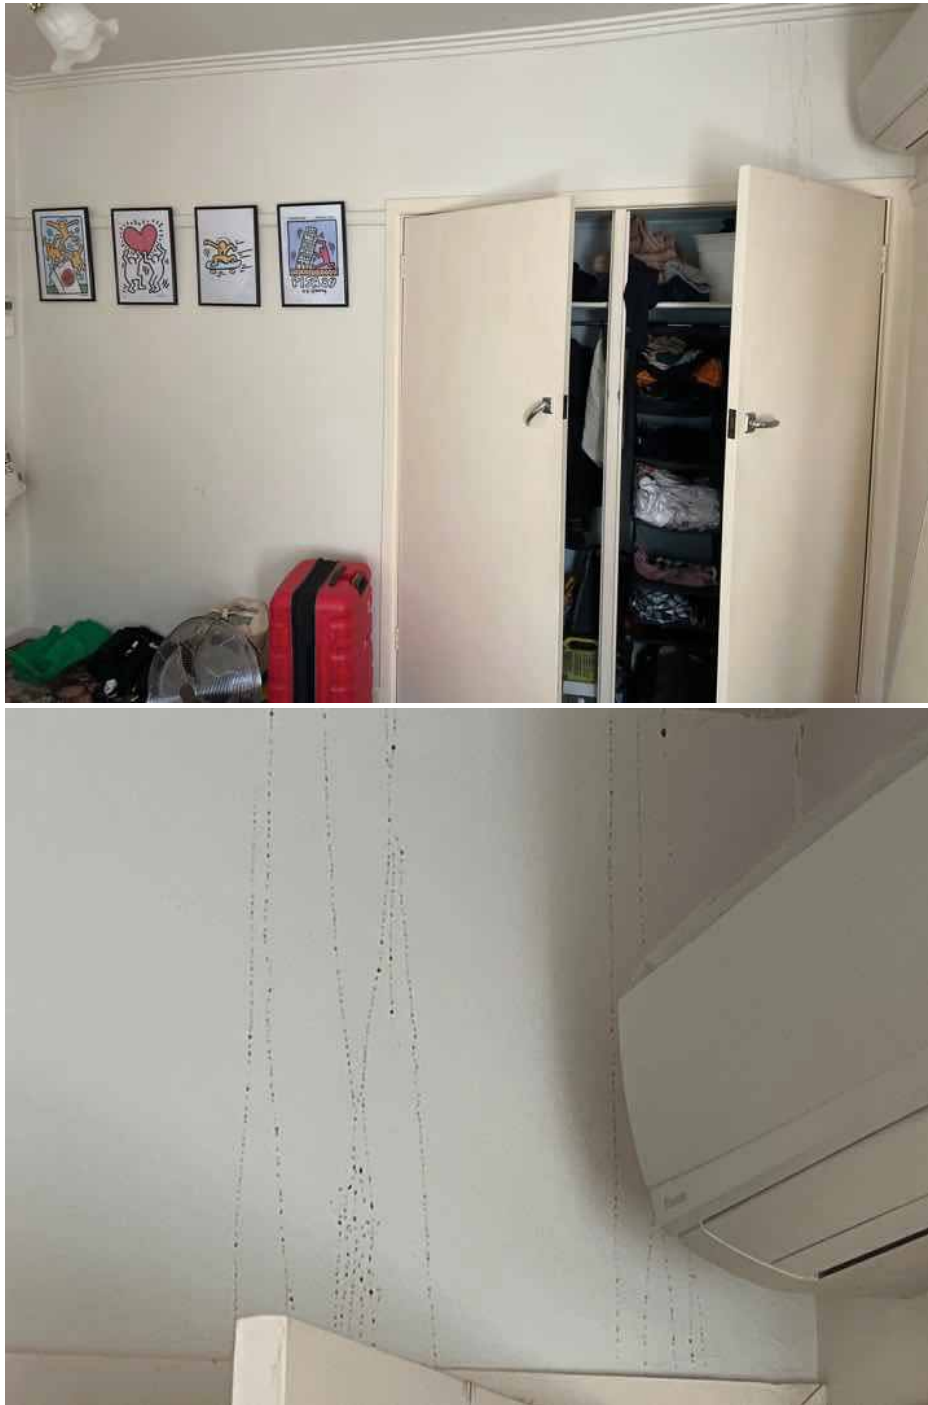
Old damp damage to wall. Tested and dry today. Repairs by a plasterer recommended.

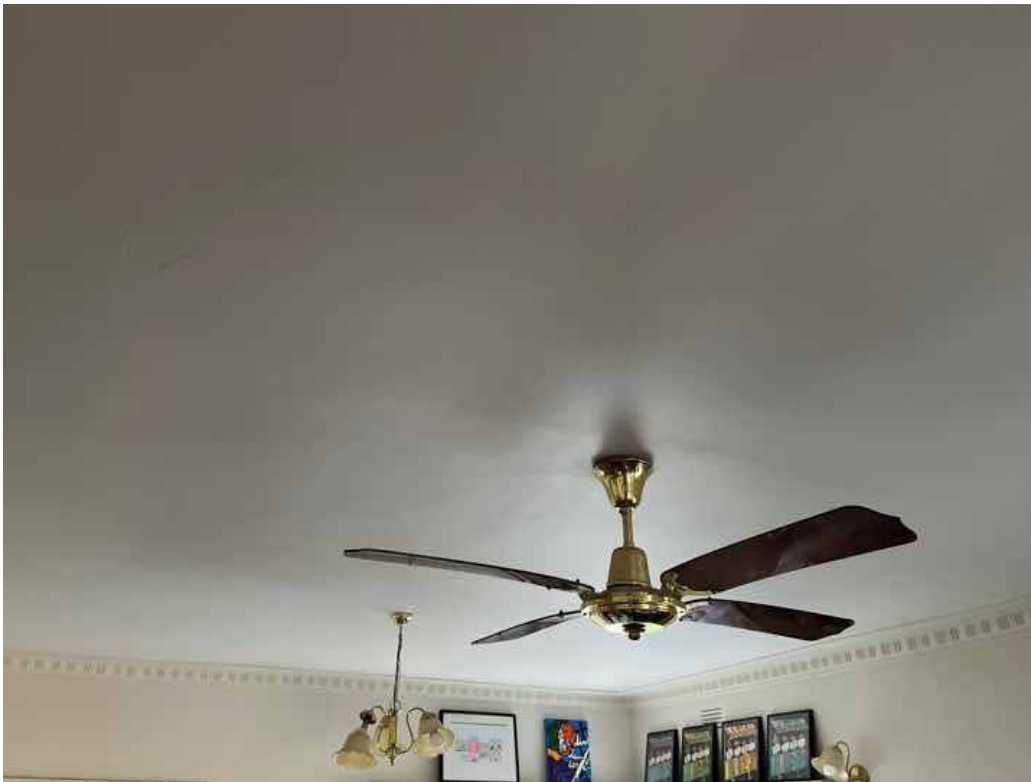
Uneven ceiling sections. Have plasterer assess.

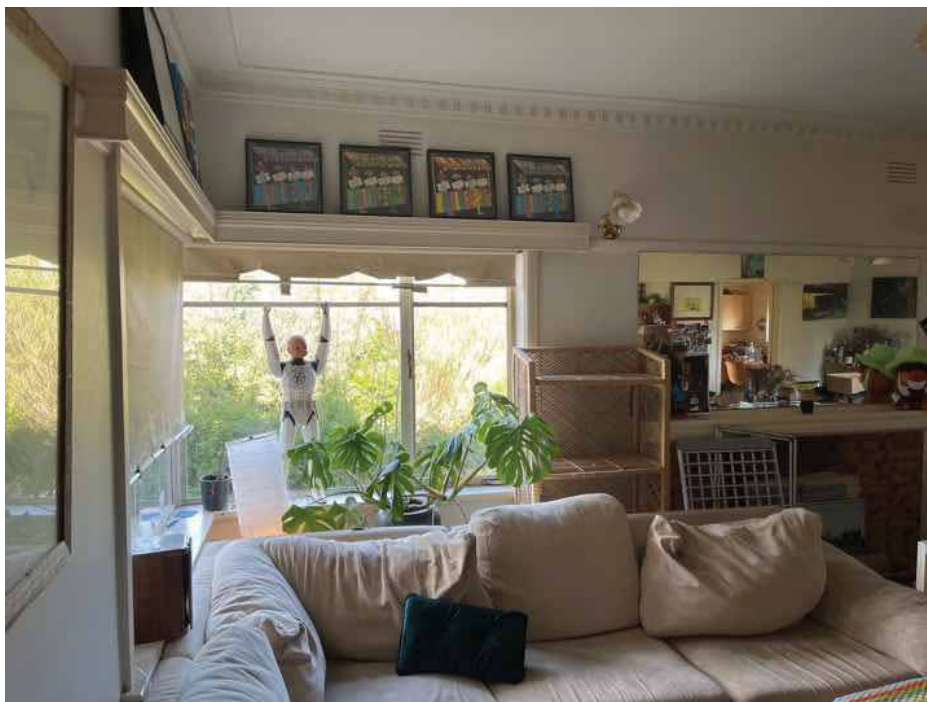
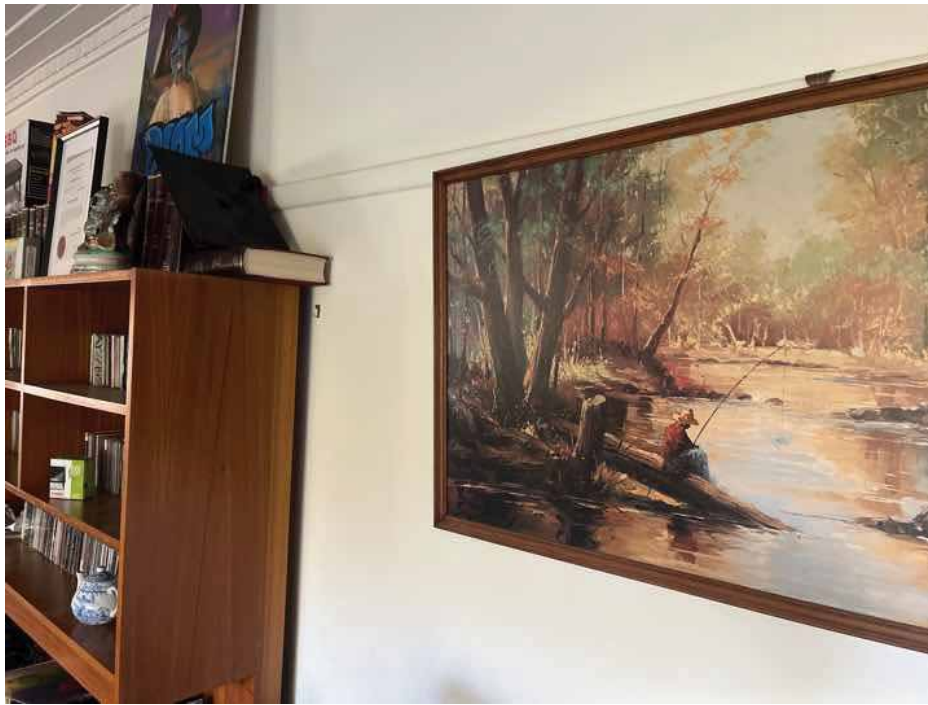
Settlement Cracks on wall areas. This can be related to differential settlement in footings, shrinkage in timber framing or poor plastering. Monitoring these cracks for 12 months is advised & if become wider or longer, you will need to contact a structural engineer to assess.

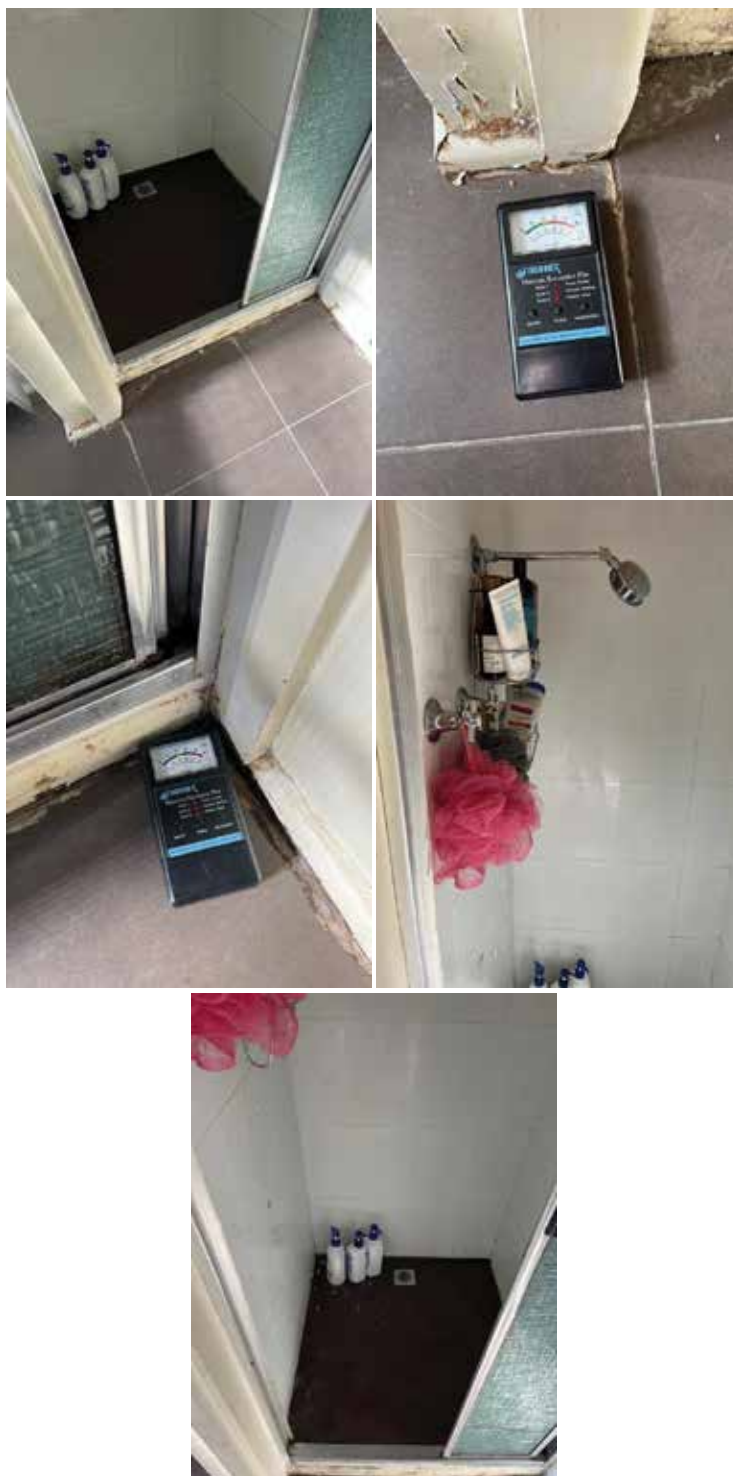
Old damage to flooring. This is possibly been caused by past leaks from the shower recess. Have a carpenter assess and repair as required

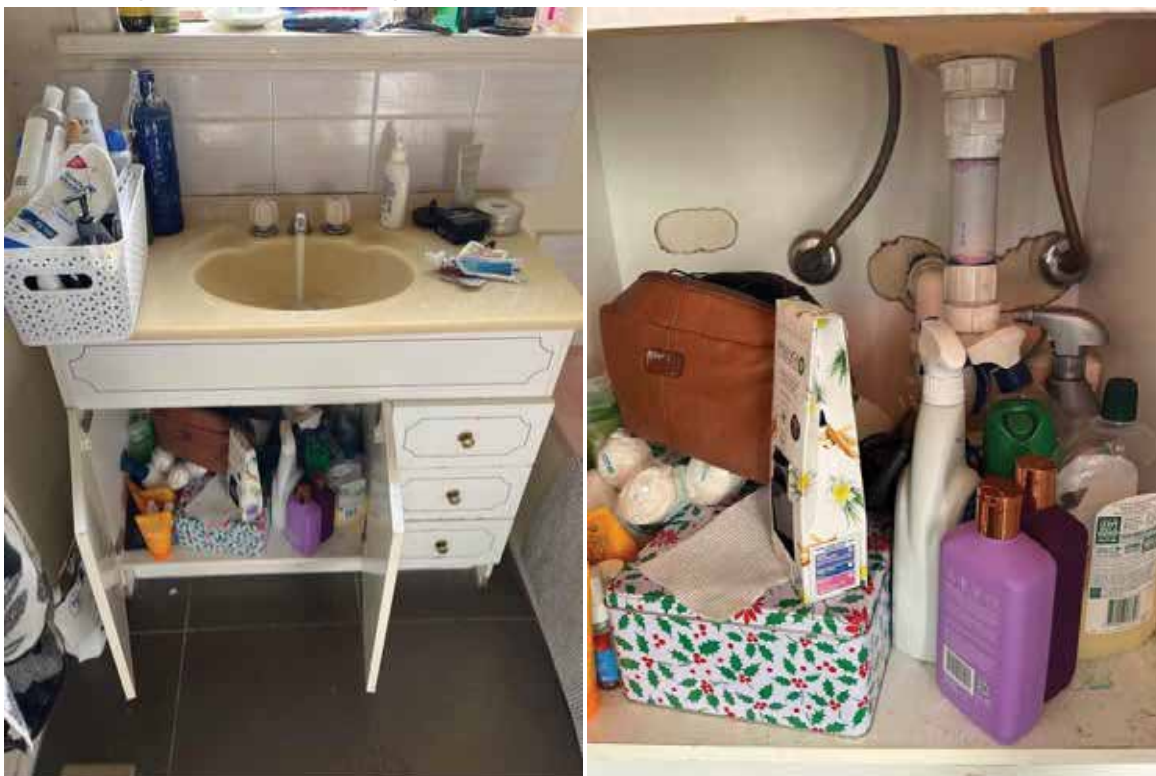
Tile grout has aged / deteriorated. Have sealed by qualified tiler.  
Blocked sink - have plumber remove trap and clean/assess.

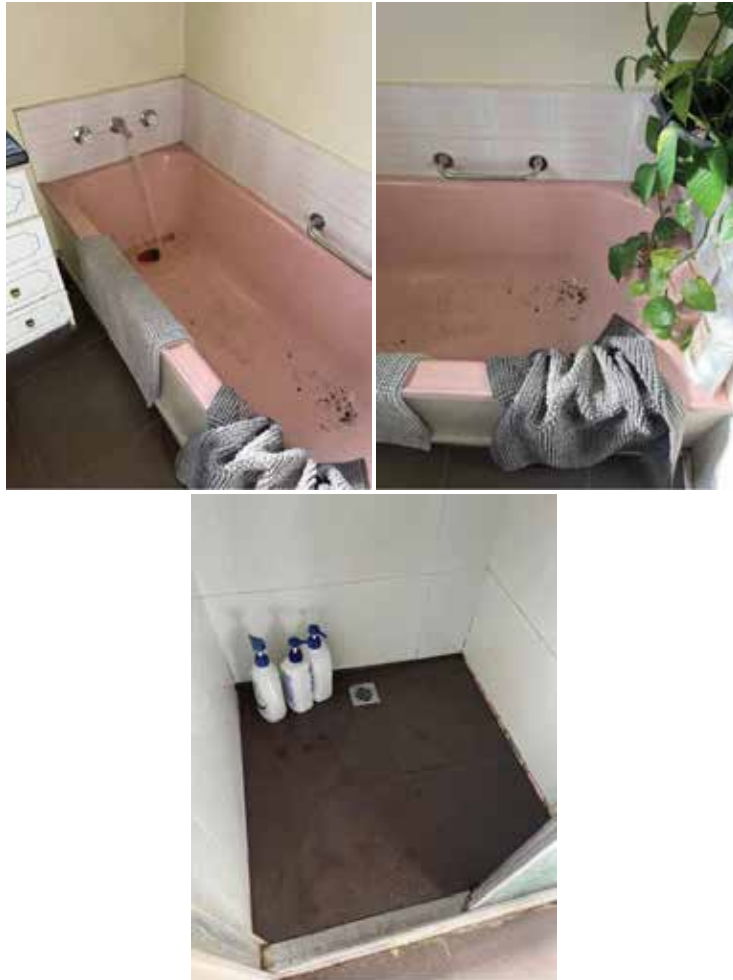
General age deterioration to bath base. Replace as required.

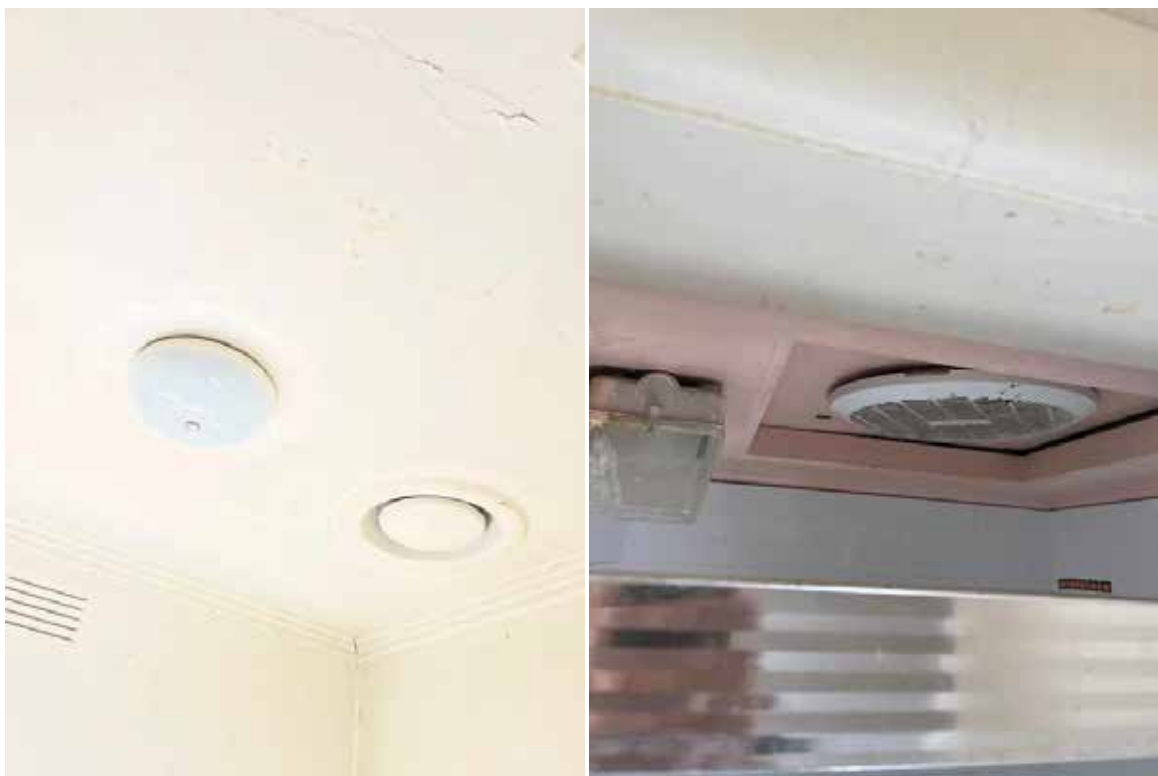
Noisy Exhaust Fan. Have assessed by an electrician. May require cleaning, replacement or securing. The exhaust fan is loosely fitted to the ceiling. Engage an electrician to rectify.

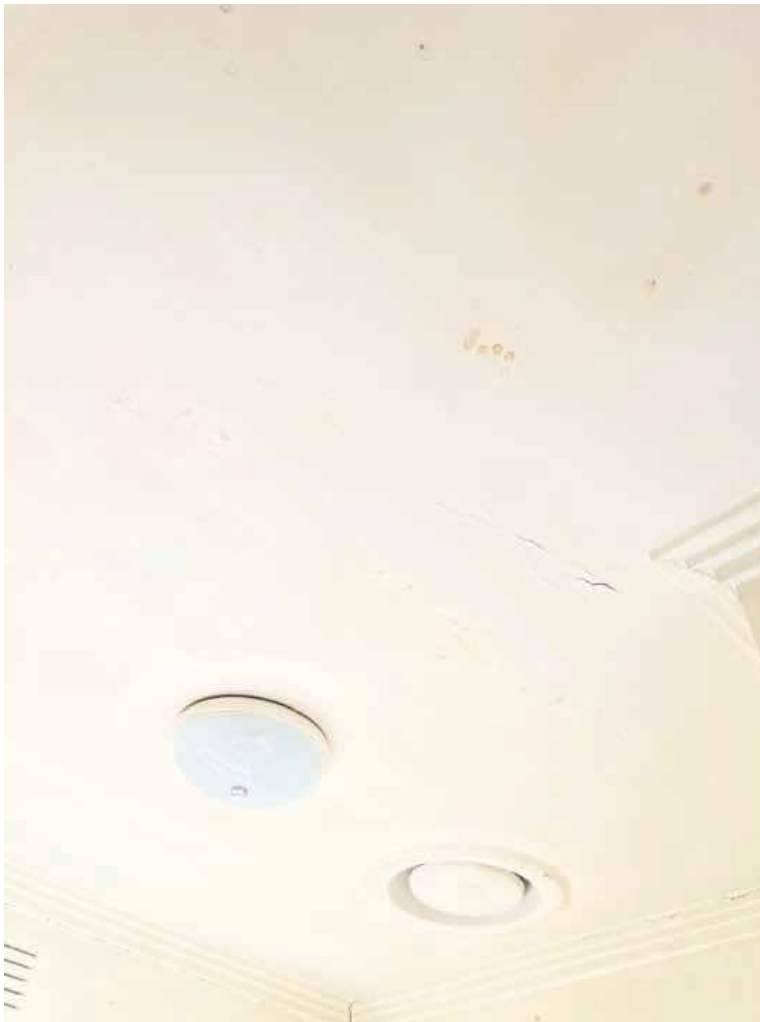
Mould evident in sections of the ceiling - we do not specifically report on mould type or hazards as per the Australian Standards AS 4349.1-2007 - we recommend you engage a mould specialist to assess & make recommendations as to cause and remedy.

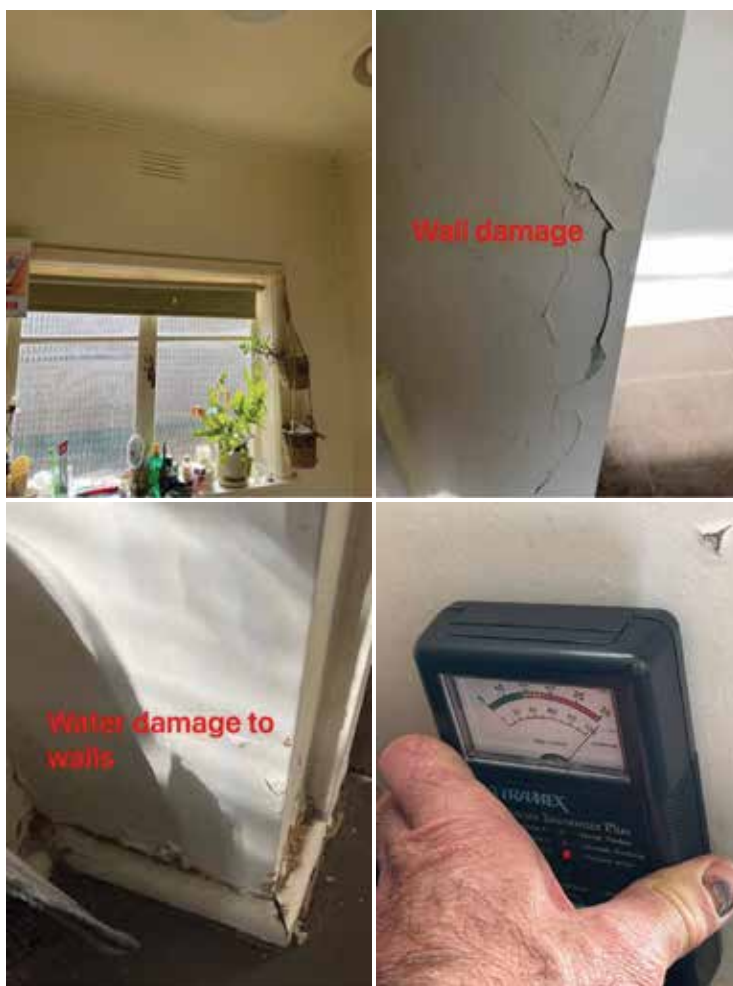
Mould evident in sections - we do not specifically report on mould type or hazards as per the Australian Standards AS 4349.1-2007 - we recommend you engage a mould specialist to assess & make recommendations as to cause and remedy.

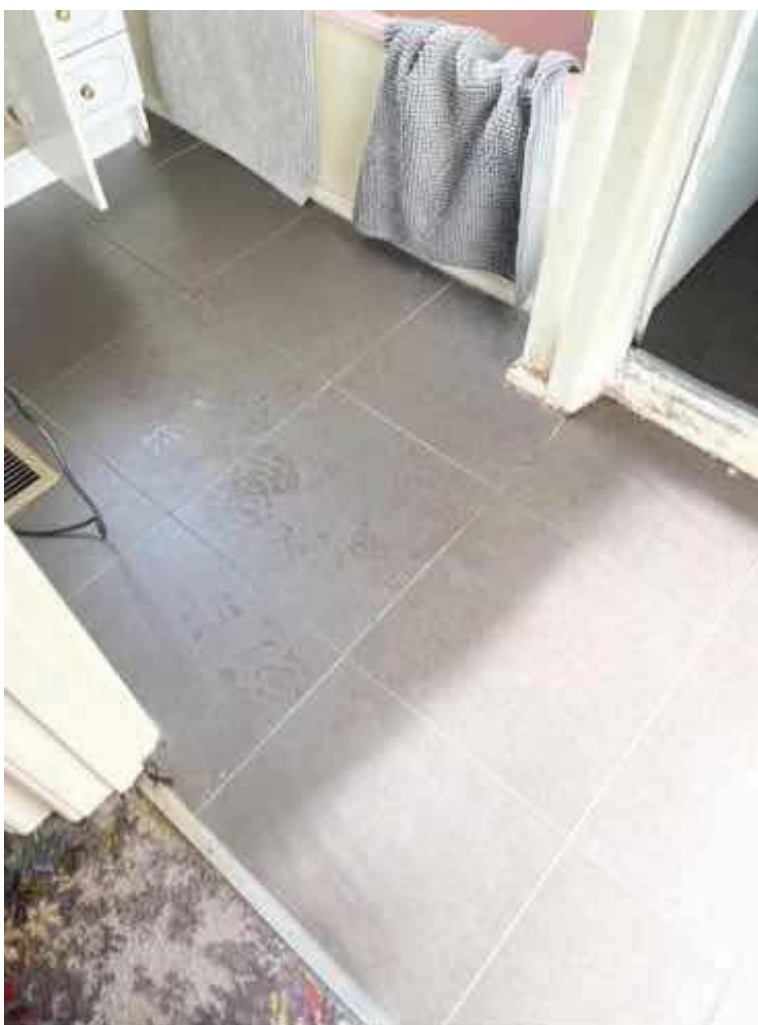
Excess moisture readings were obtained on the floor areas near the shower recess - This may be related to possible shower recess/tiles/base/pipe connection leaking. Engage a licensed plumber to ascertain if pipe leak related or shower recess water proofing is required. We cannot guarantee that timber wall/ floor framing members behind showers/wet areas are not damaged by water unless an invasive inspection is conducted which I strongly advise you have conducted.

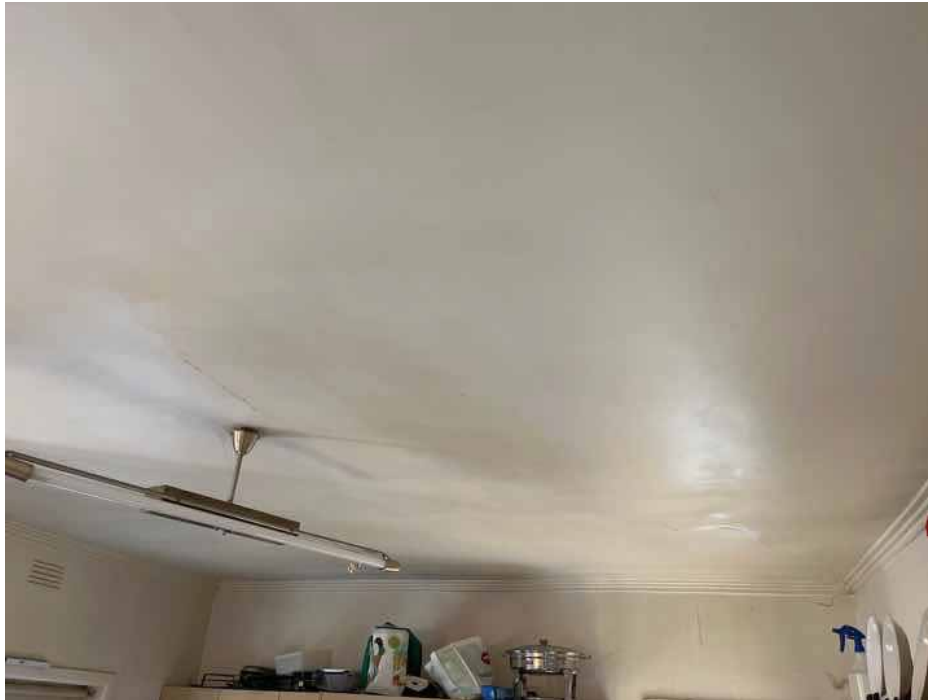
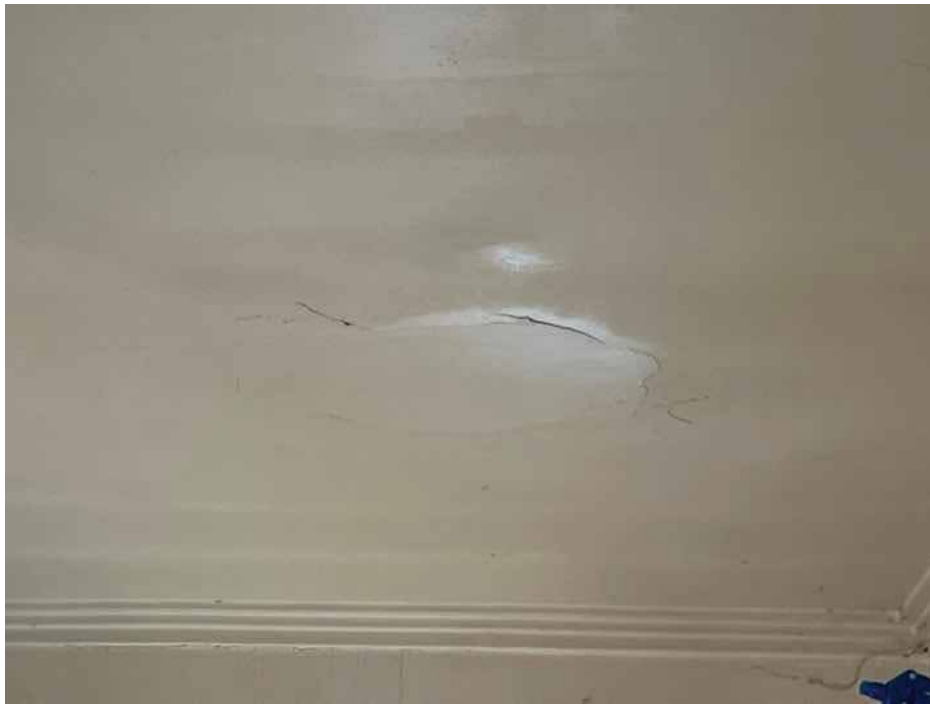
Ceiling stains - Appear to have emanated from Roof Area. No moisture readings obtained from same. These may have been repaired, however a qualified plasterer should be engaged for advice and recommendations and to assess damage to plaster and inaccessible framing.

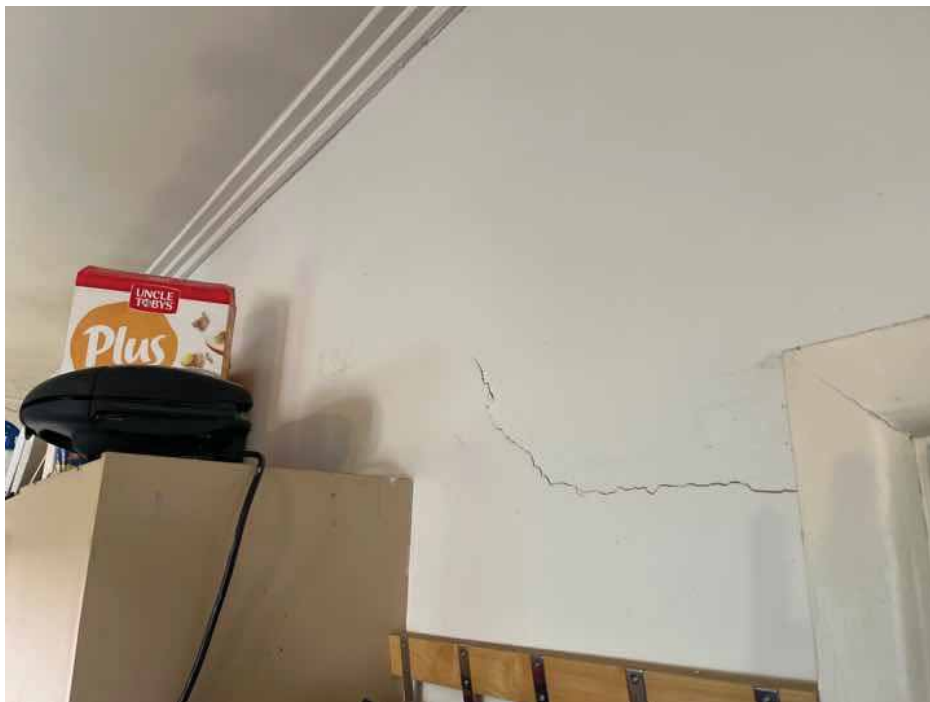
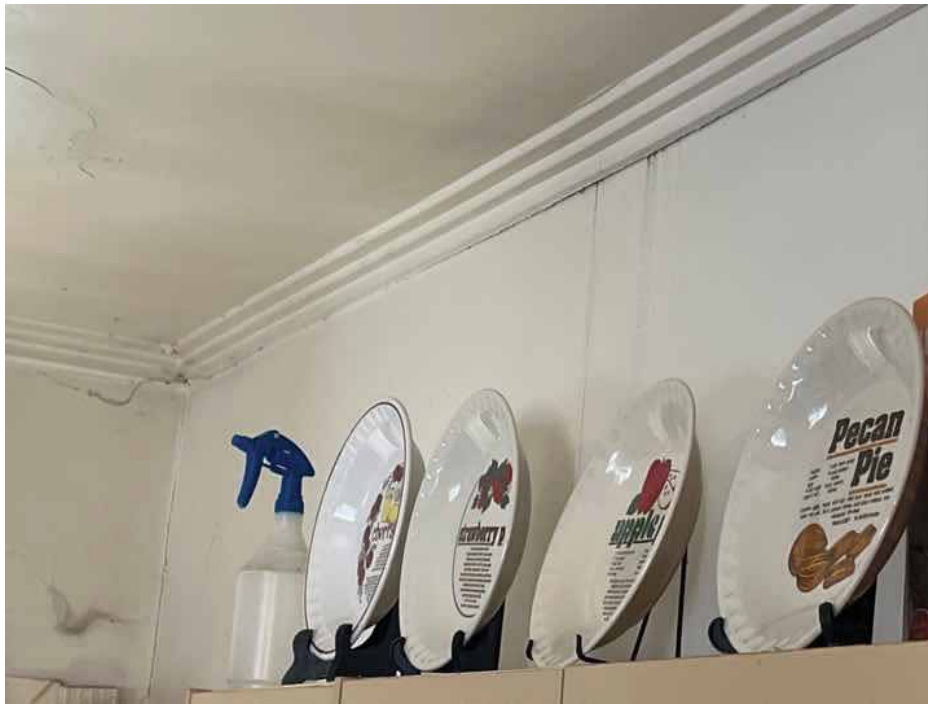
Wall stains - Appear to have emanated from Roof Area. No moisture readings obtained from same. These may have been repaired, however a qualified plasterer should be engaged for advice & recommendations and to assess damage to plaster & inaccessible framing.
