# Inspection Report

**Safehome PTY LTD**

**1 Smith St, Pennydale, VIC, 3192**

Report/Agreement #	2305230921506
Inspection Date:	23 May 2023
Inspection Time:	11:00 am

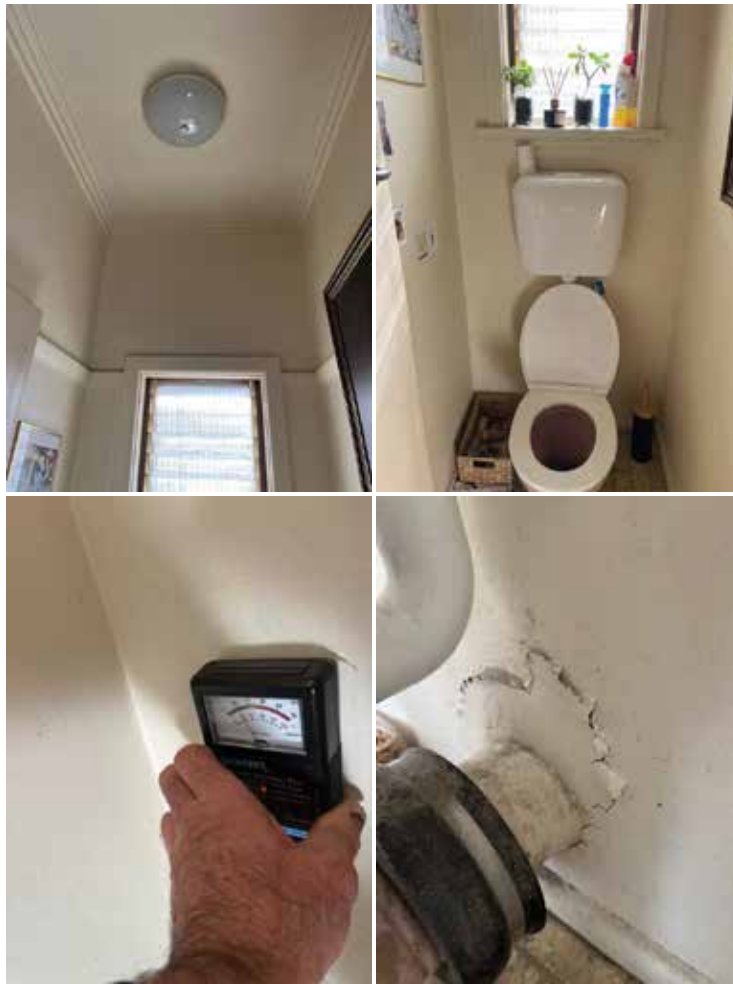
Settlement Cracks on wall areas. This can be related to differential settlement in footings, shrinkage in timber framing or poor plastering. Monitoring these cracks for 12 months is advised & if become wider or longer, you will need to contact a structural engineer to assess.

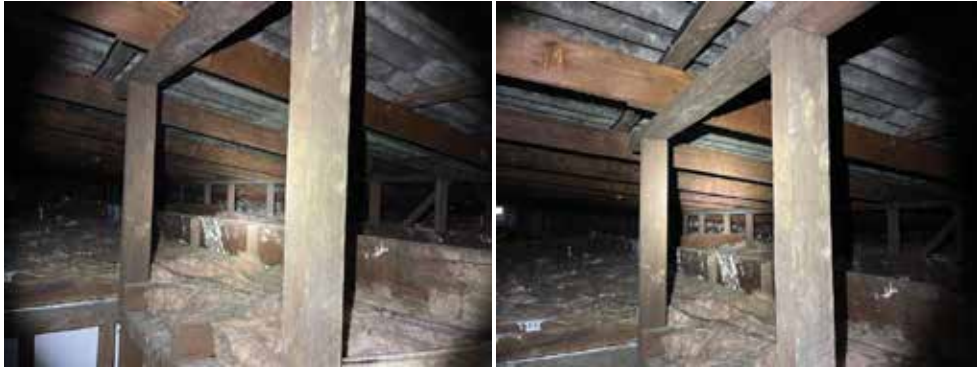
The strutting of the roofing is considered inadequate/poorly fixed - Engage a qualified Carpenter to assess.
