# Inspection Report

**Safehome PTY LTD**

**1 Smith St, Pennydale, VIC, 3192**

Report/Agreement #	2305230921506
Inspection Date:	23 May 2023
Inspection Time:	11:00 am

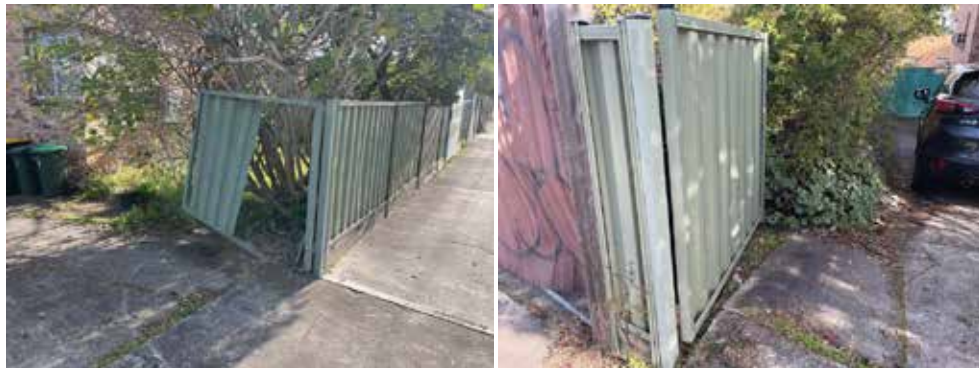
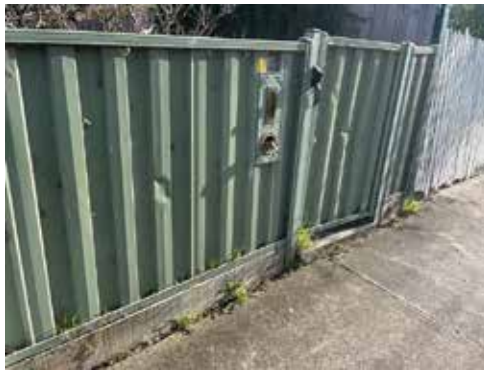
Gate has detached. Have rectified by trades person.

The inspector did not brake fence timber open or dig grounds around the base of the posts. Any leaning or unevenness is typically indicative of fence post rot subsurface and repairs by a fencing contractor must be carried out as soon as possible due to safety concerns.

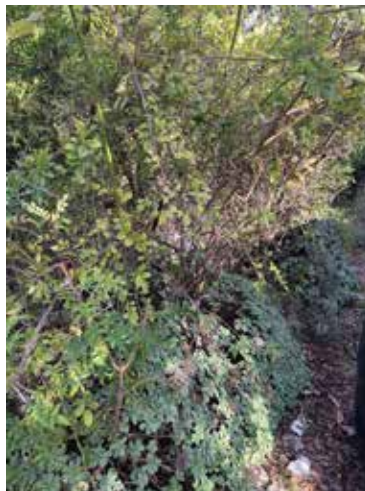
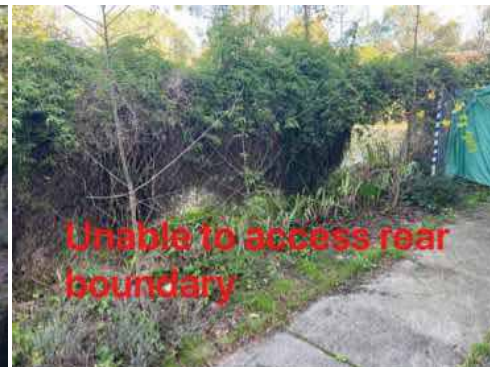
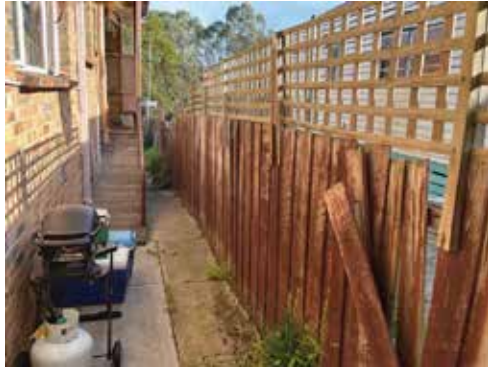
Fence rails detached due to rot or deterioration. Repair as soon as possible. Not safe to climb on and possible collapse. Safety Hazard.

Plants are covering some fence areas & Not able to thoroughly inspect for defects.

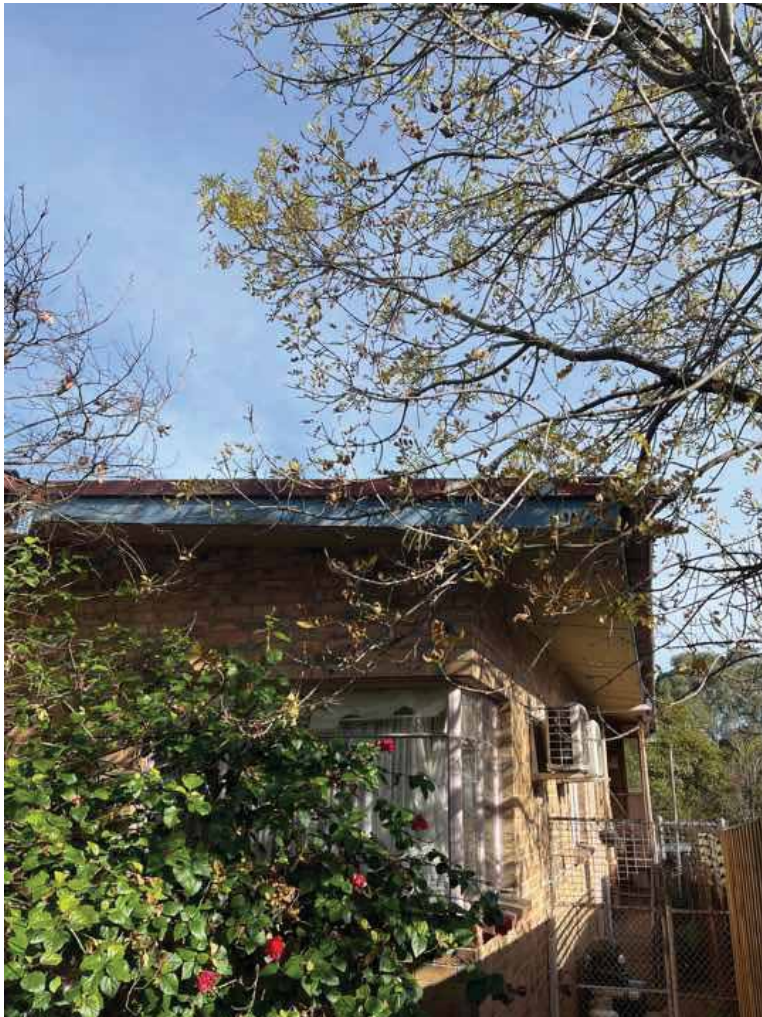
Trees are overhanging the roof in areas. This will cause gutter and down pipe blocks and I recommend you cut them back away from the roof.

Where trees are too close to the house this could affect the performance of the footing as the moisture levels change in the ground. A geo-technical inspection can determine the foundation material & provide advice on the best course of action with regards to the trees. Please download & read the CSIRO's maintenance guide relating to trees.

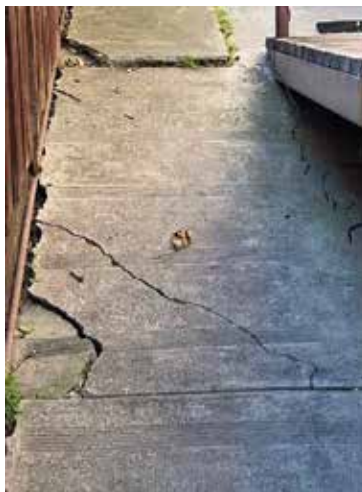
SITE	PATHS	Path Condition	The driveway is being adversely affected by tree roots. This should be rectified & repairs carried out.

The driveway is in poor condition & replacement by concreter recommended.

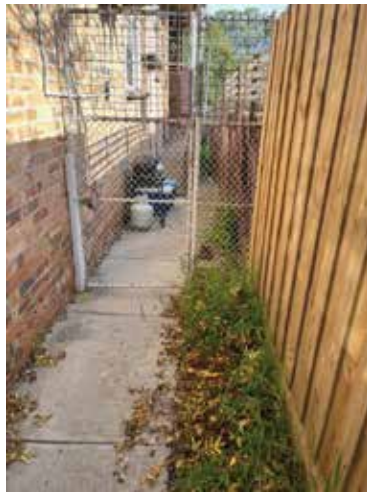
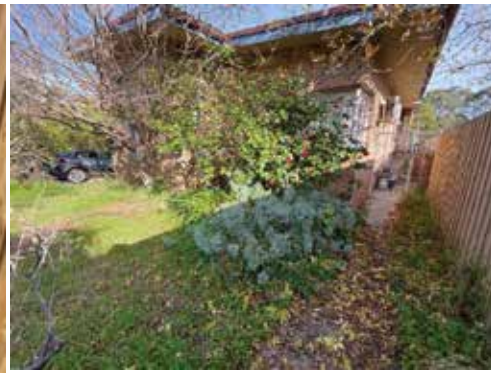
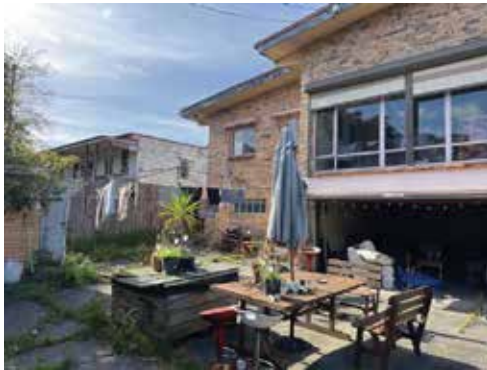
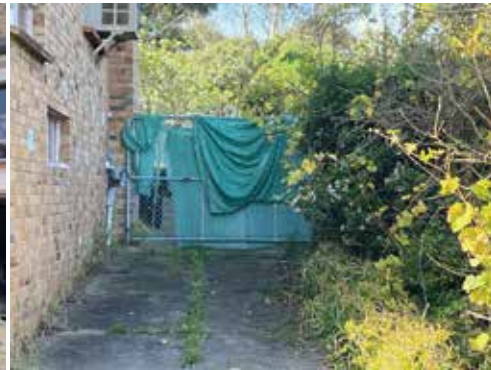
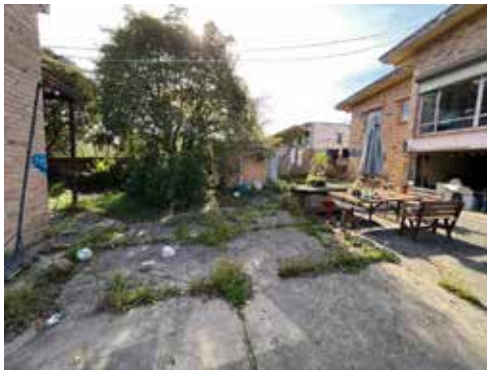
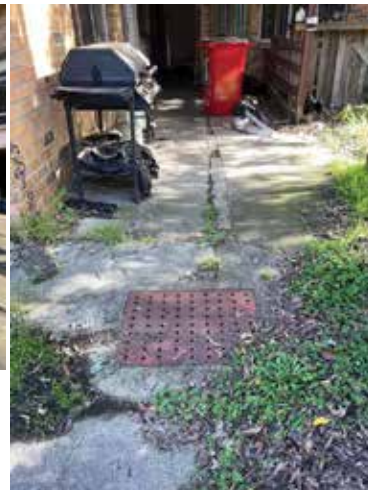
Excessive growth - unable to assess. Cut back and re-assess.

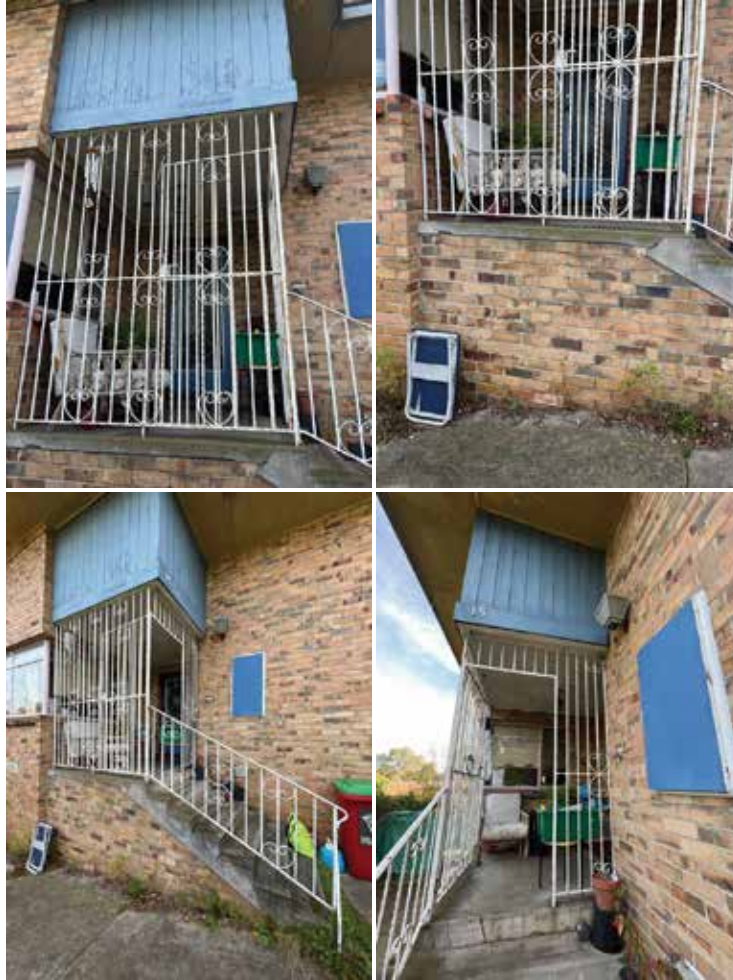
On inspection, defects were noted that may require further assessment & recommendations by licensed tradesperson.

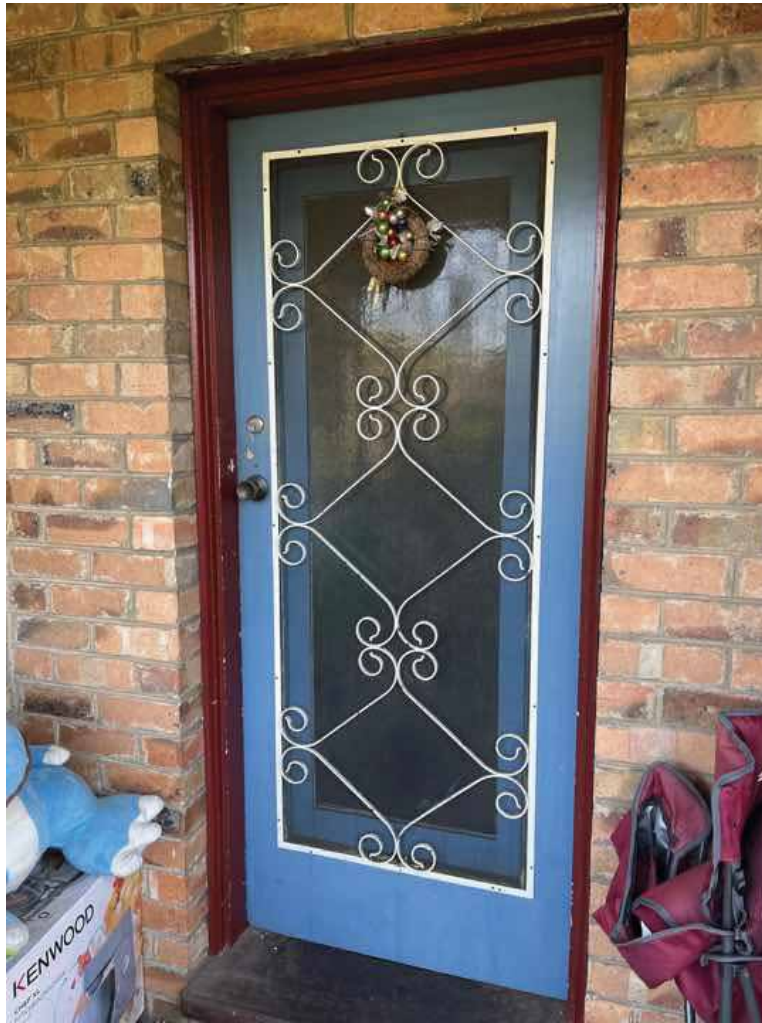
General age and/or wear and/or deterioration to door/components - General maintenance works required.

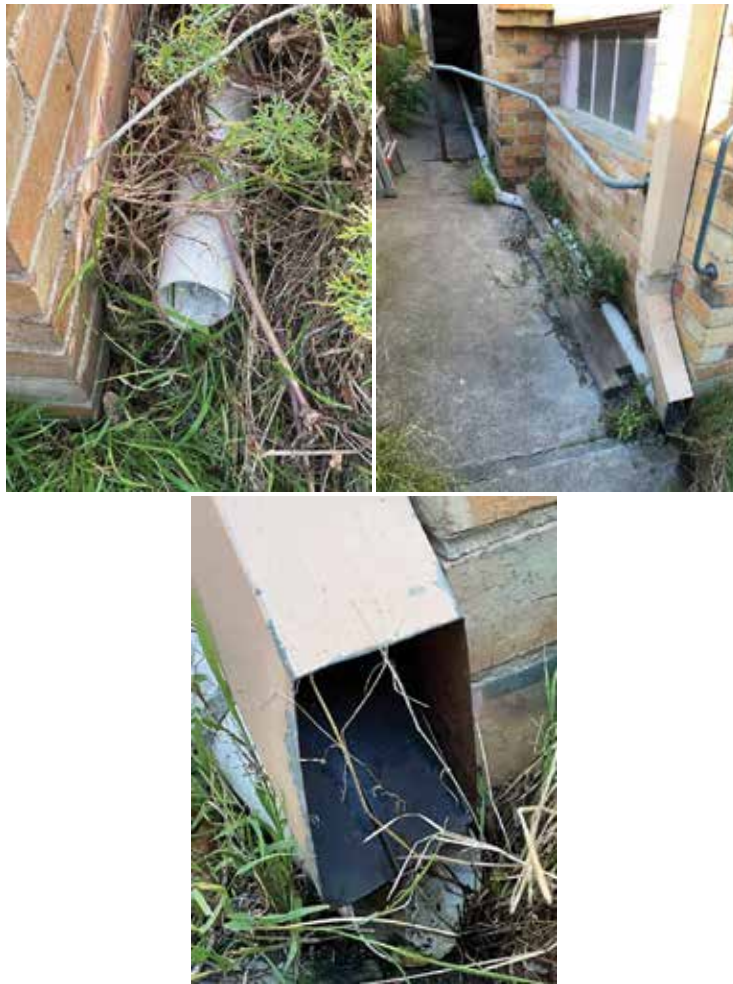
Rust penetrations in down pipe. Over time, this has potential to cause differential settlement to the footings and rising damp in Masonry dwellings. A qualified plumber should be engaged to replace.

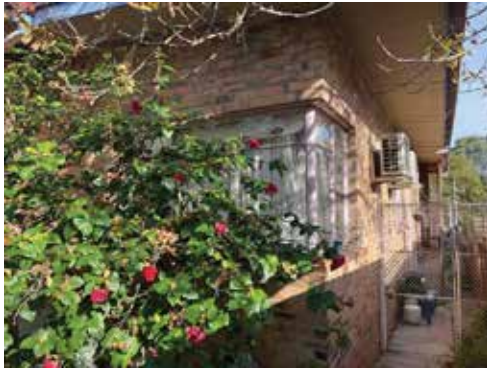
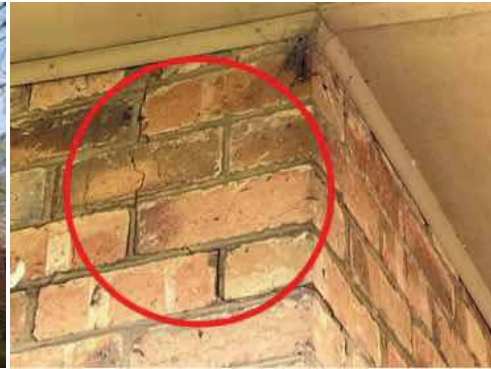
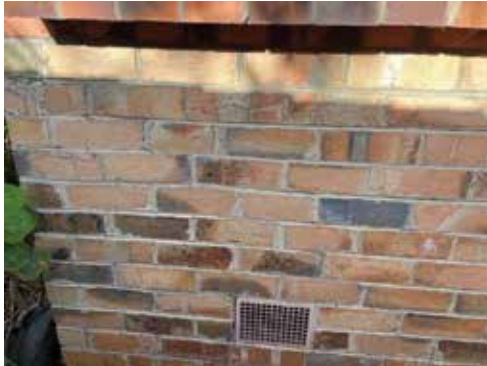
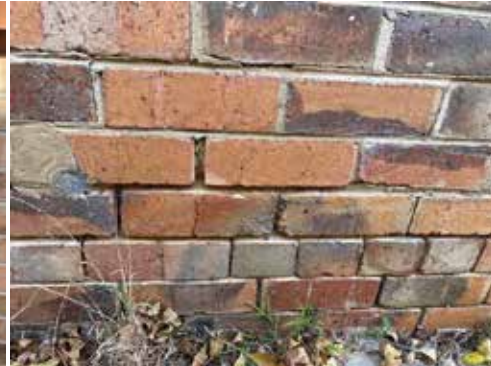
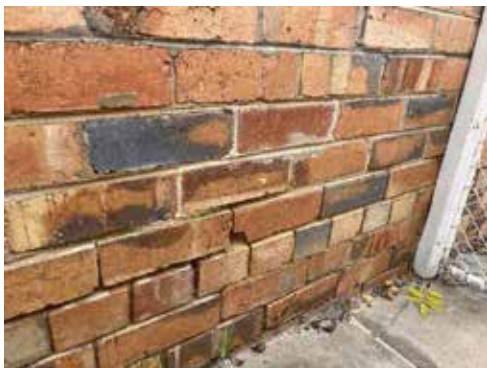
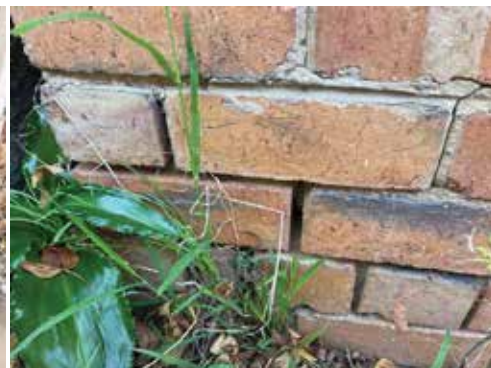
Brick fretting on wall section/s. This can be associated with damp/drainage issues. Further investigation required by a qualified damp proofing & drainage specialist for advice & recommendations.

Damaged brick/s sections. Engage brick layer to assess / replace.

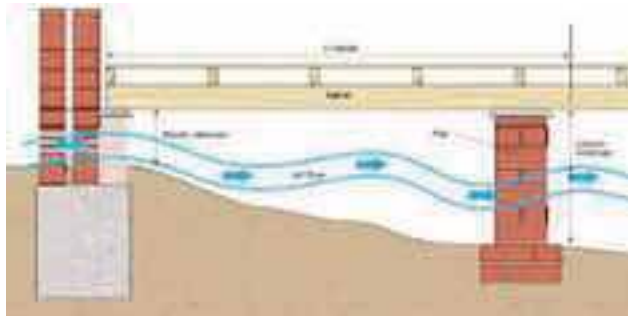
Subfloor ventilation is acceptable.

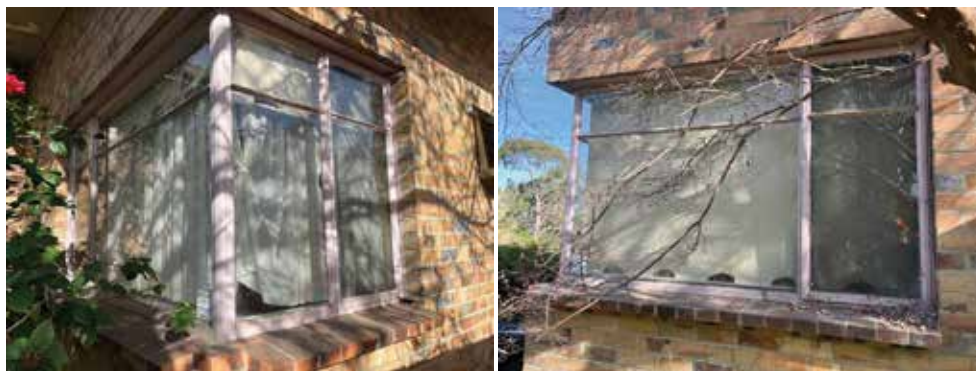
General ageing / deterioration in areas of windows/components. General upkeep or maintenance advised.

Sections of the external windows have paint deterioration - Engage a qualified painter for repairs.

Deterioration of sections of window putty was observed - A qualified glazier should be engaged for minor repairs.

Window pane cracked. Engage a qualified glazier to repair/replace as soon as possible. Cracked windows can be a safety hazard.

Lintel rust in sections. This may cause cracking in wall linings above the window - A qualified brick layer should be engaged for repairs & recommendations regarding restricting rust or replacement.

Rust is evident in sections of the homes window framework. Some areas should be repaired. A qualified carpenter should be engaged for advice & recommendations regarding restriction of rust.

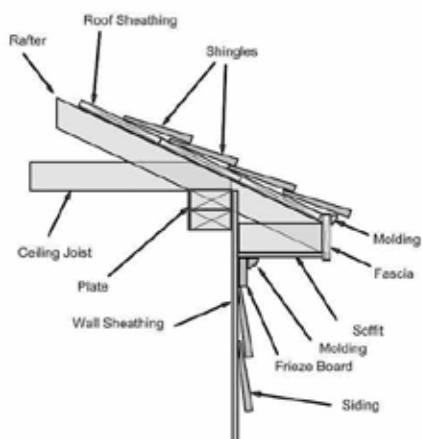
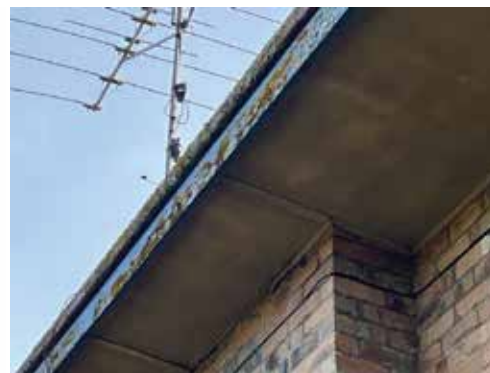
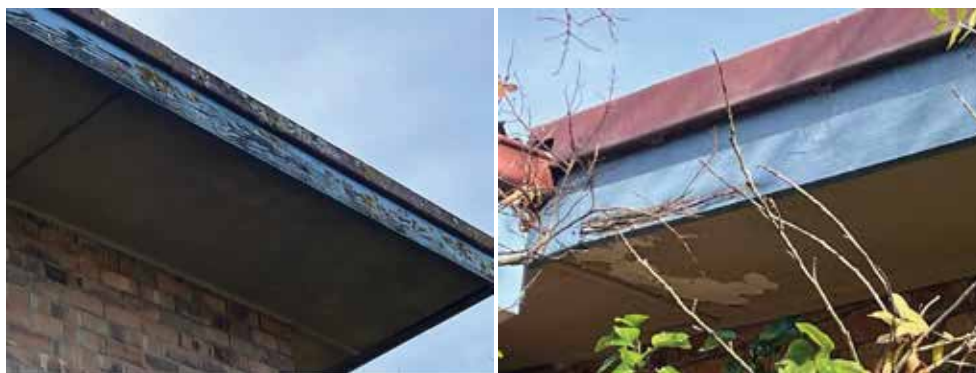
Fascia

Minor deterioration & ageing evident to timber fascia. Maintenance works, general upkeep should be carried out. Timber fungal decay (rot) visible. A qualified carpenter should be engaged to repair/seal all affected timbers.

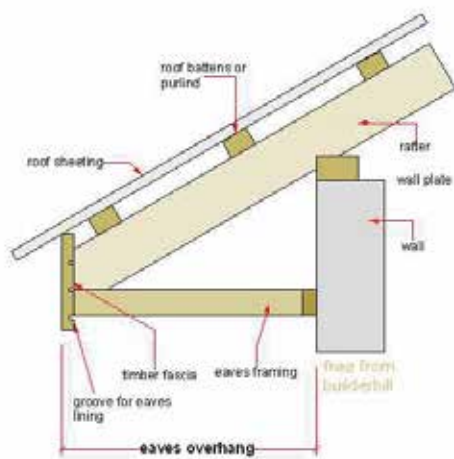
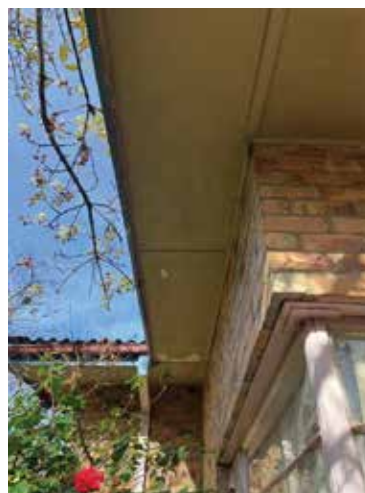
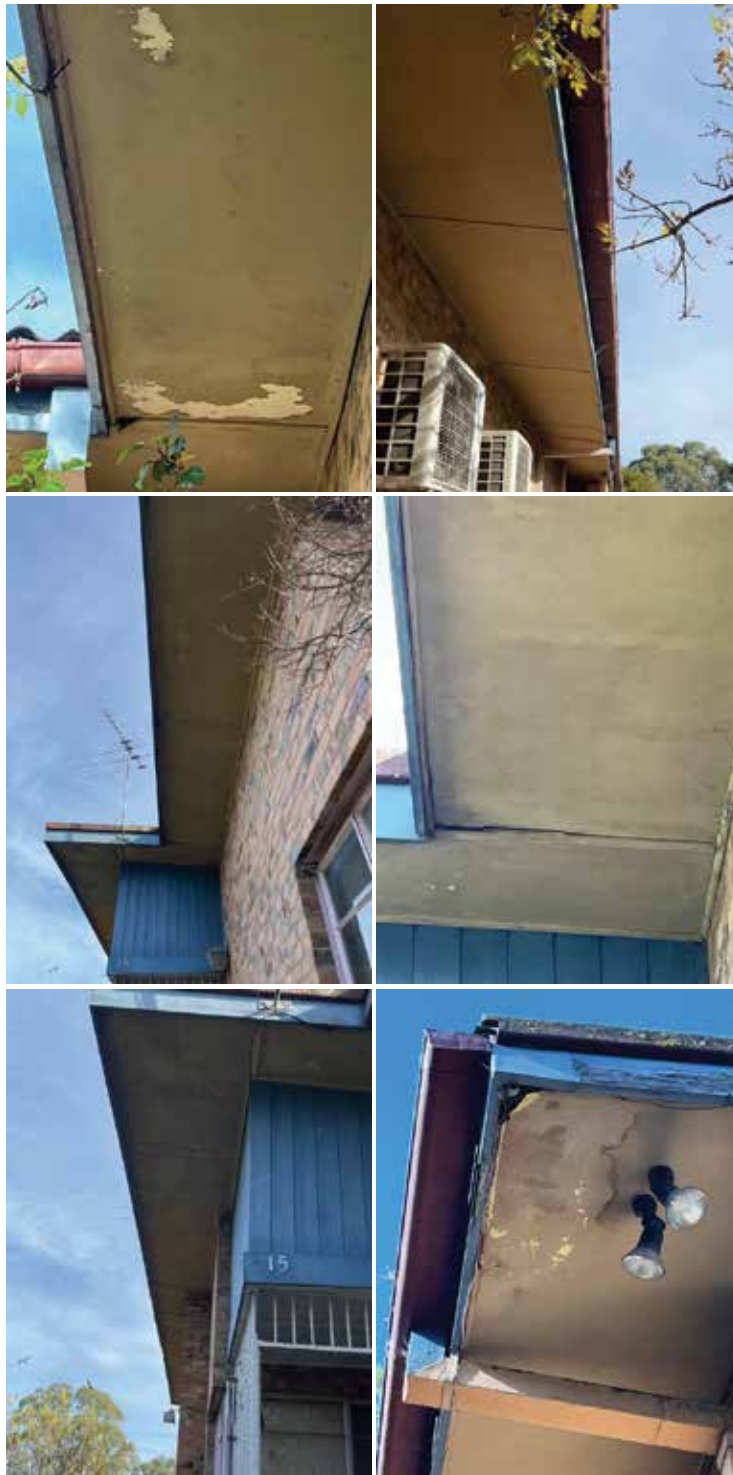
Minor eave deterioration & ageing evident - Maintenance works, general upkeep should be carried out. Fibrous Cement Sheeting sections. We recommend an ASBESTOS Inspection be conducted by a licensed Asbestos Inspector prior to a decision to purchase.

Timber fungal decay visible in sections - A qualified carpenter should be engaged to assess/repair.

Sections of the Eaves have paint deterioration - Engage a qualified painter to paint/seal.

Quad deteriorated or detached in areas - Contact a Licensed carpenter for minor repair or replacement.

Eave lining stains detected in sections. Appears current leak related. Engage a licensed plumber for to assess/repair as required.

Eaves damaged in sections. Replace at leisure.

Eave detached in areas. Have carpenter repair.

Staining under pipe penetration. Likely a flashing leak. Have plumber assess and repair as required.

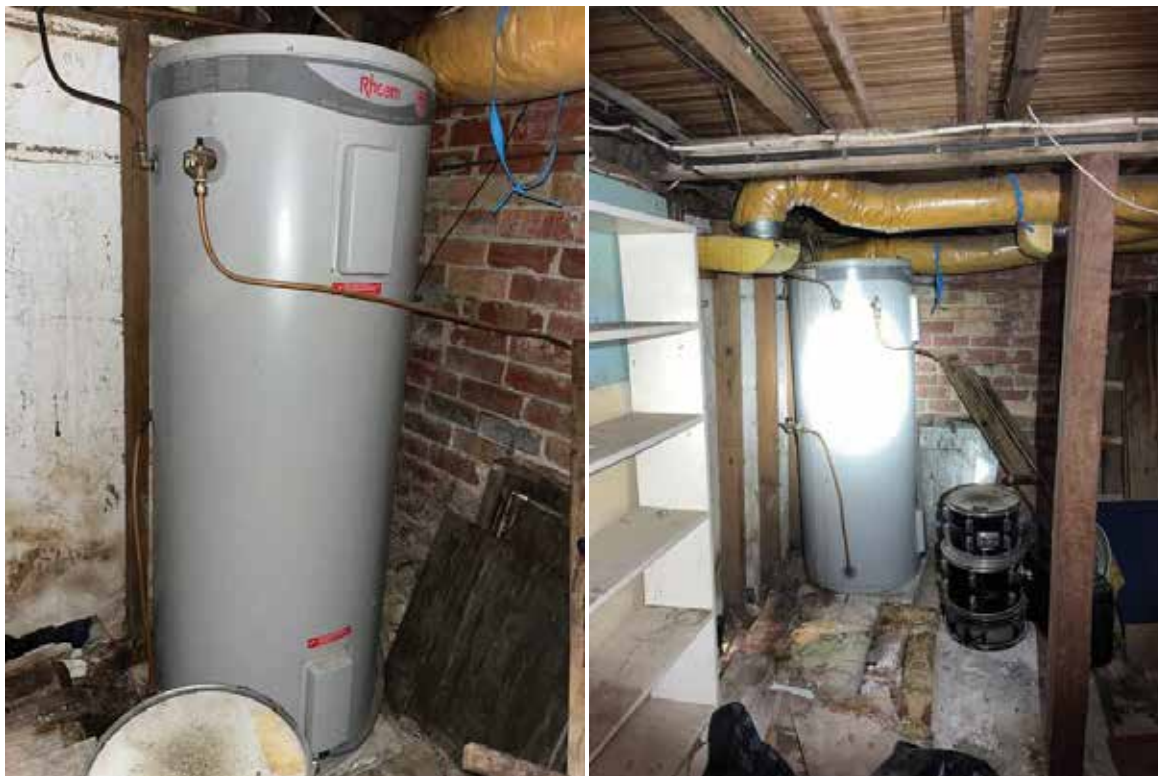
The hot water system appears to be in a serviceable condition. No specific tests other than running the hot water from a tap was carried out. No determination has been made as to the suitability or adequacy of the hot water system in relation to capacity or otherwise.

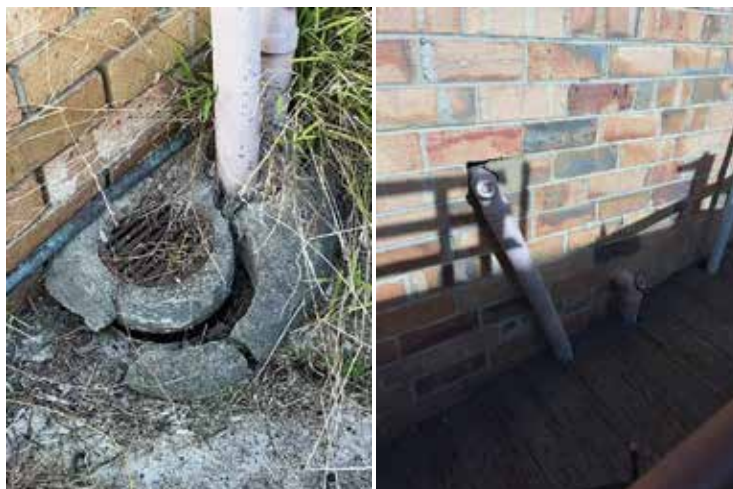
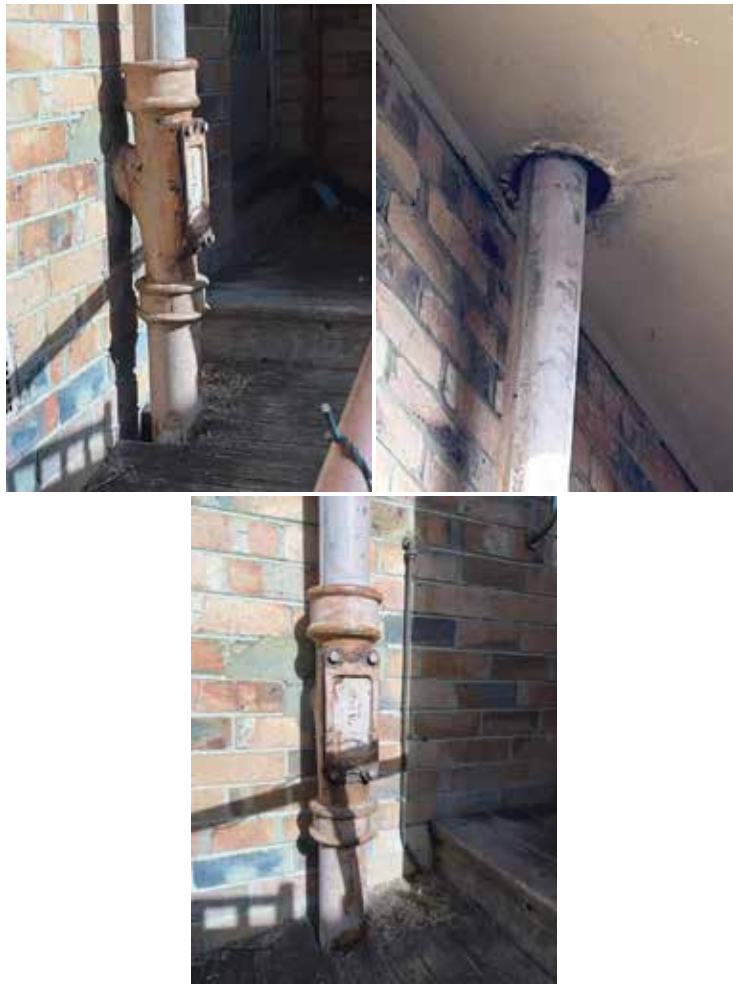
Opening/gaps between plumbing & wall penetration - Plumbing holes are defective if they are not properly grouted. Engage a brick layer or plumber to rectify.

Settlement/cracking visible in sections of the plumbing concrete base connection - Engage a qualified plumber for advice & recommendations.

The plumbing is poorly sealed to the base drain in areas - Engage a qualified plumber to seal to avoid blocking.

Rusted pipe work - Have plumber assess & repair as required.

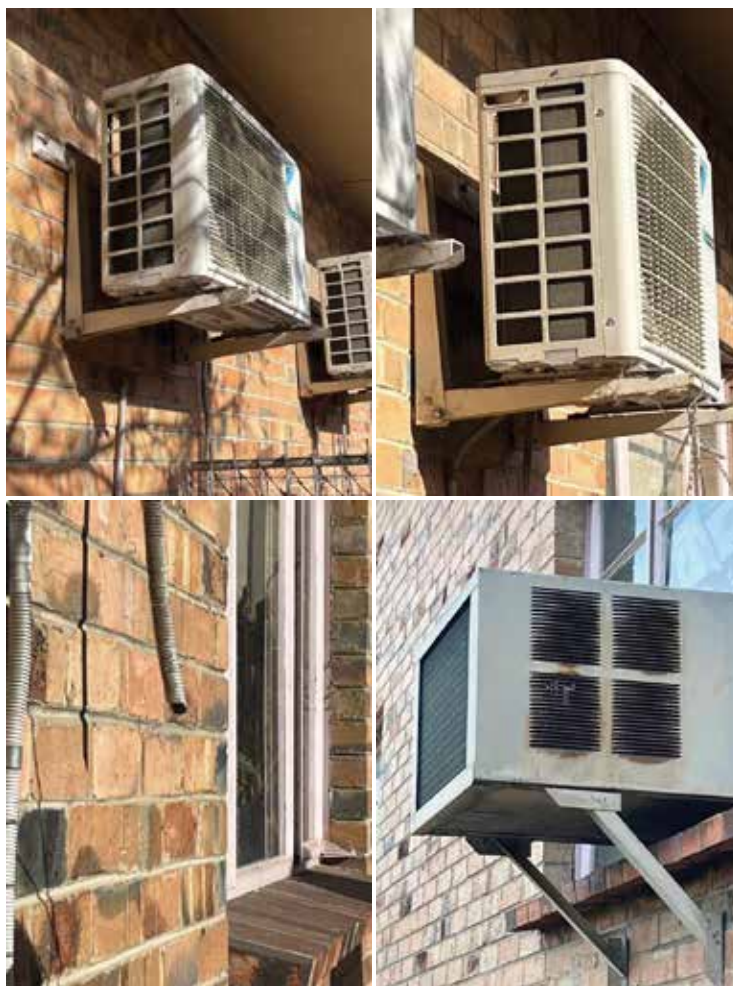
The split system overflow requires diverting to a drain or further from the dwellings wall or footings. Excess water ponding alongside walls & into perimeter footings has the potential to cause rising damp, differential settlement & wall cracks over time. It is also conducive to termite infestation. Engage a plumber to rectify.

Rust deterioration evident on heating or cooling unit sections - Engage a qualified plumber for advice & recommendations.

General Age and/or Damage to unit/s. Engage a heating/cooling contractor to assess & test.

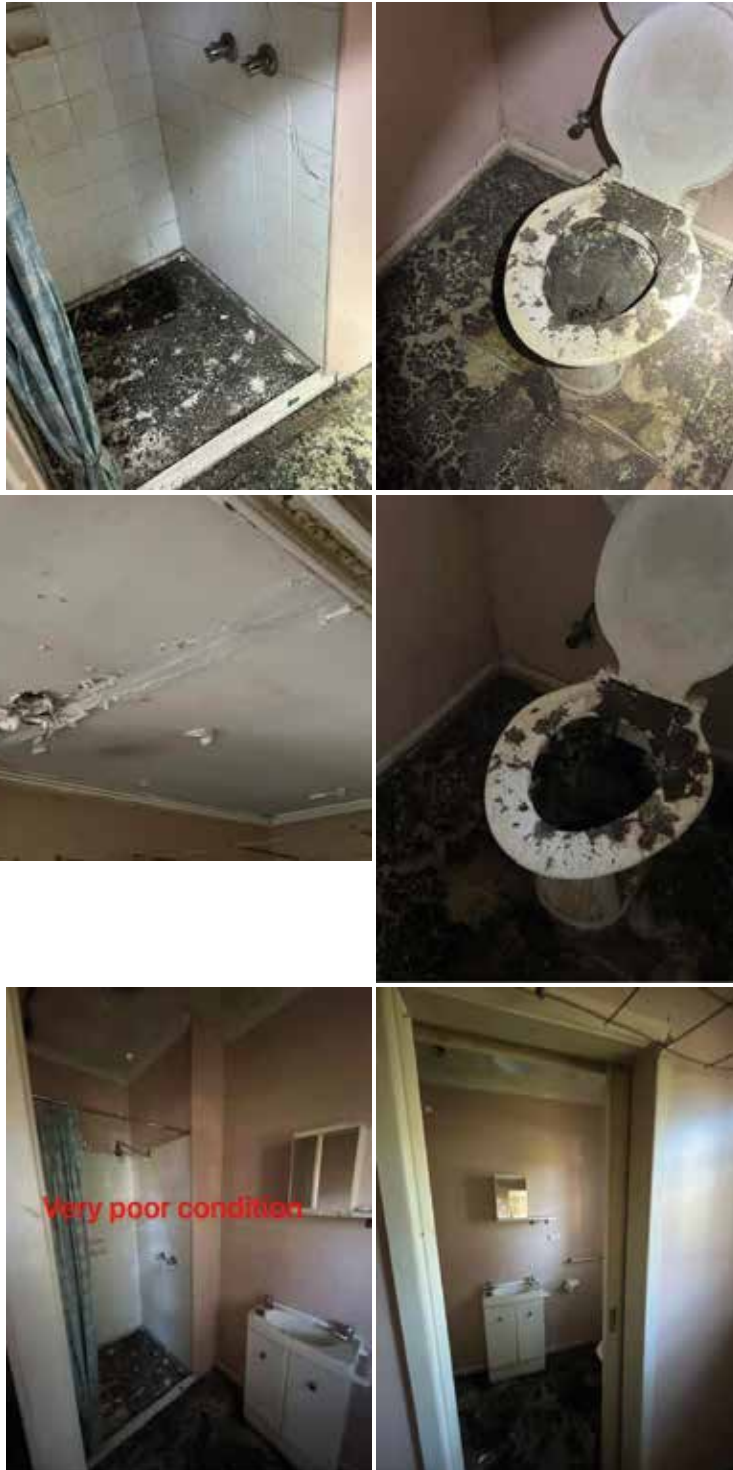
The door has been removed.

Old damage to flooring. This is possibly been caused by past leaks from the shower recess. Have a carpenter assess and repair as required

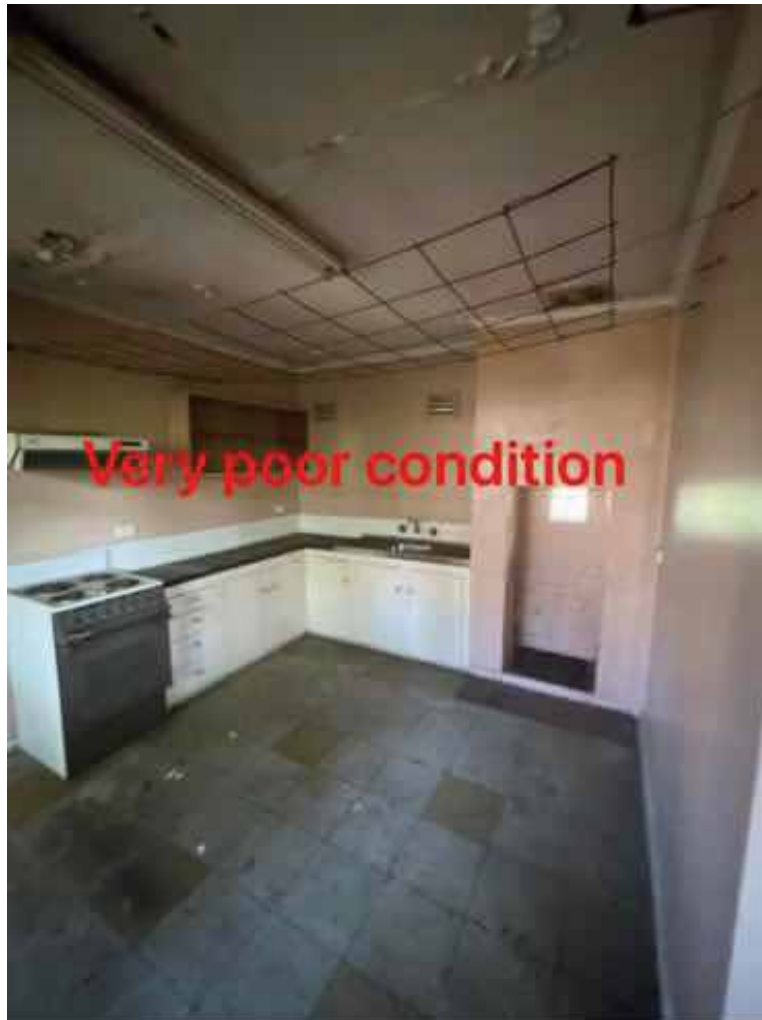
General ageing & deterioration of the sink, cupboards and benches - Update kitchen as required.

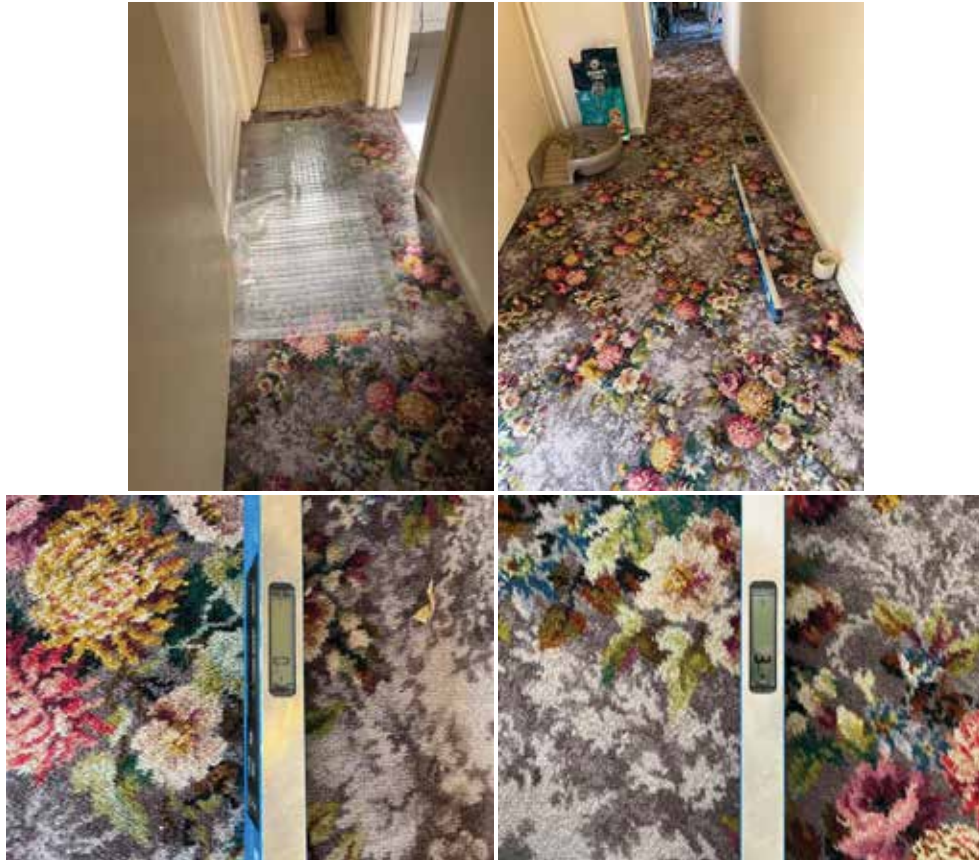
General age, deterioration or wear and tear to sections of the floor linings. General repair and maintenance advised.

Minor creaking in flooring sections - In some circumstances this can be due to workmanship, fixings loosened/ deteriorated, dampness/rain during construction. A qualified carpenter should be engaged to ascertain cause & remedy.

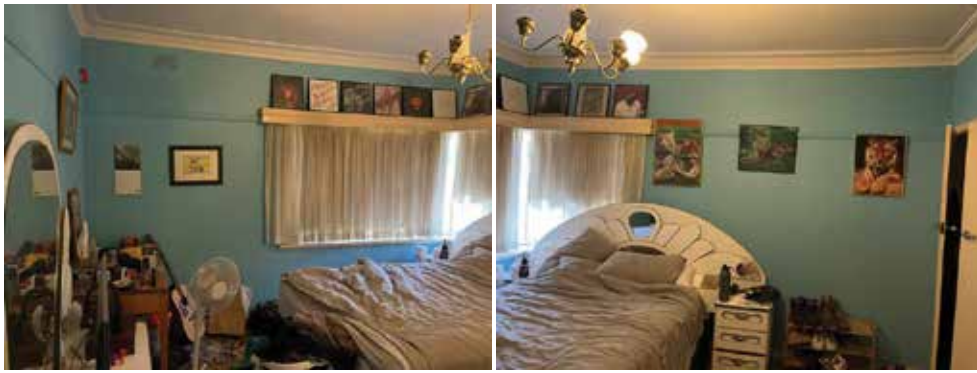
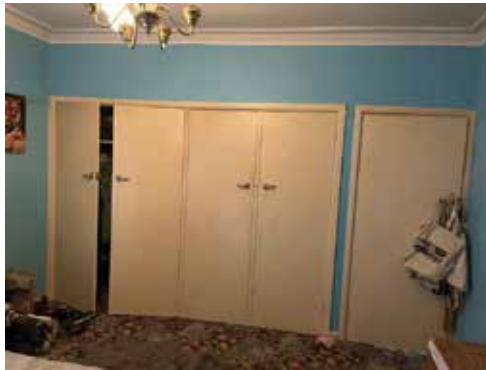
General age and/or wear and/or deterioration to door/components - General maintenance works required.

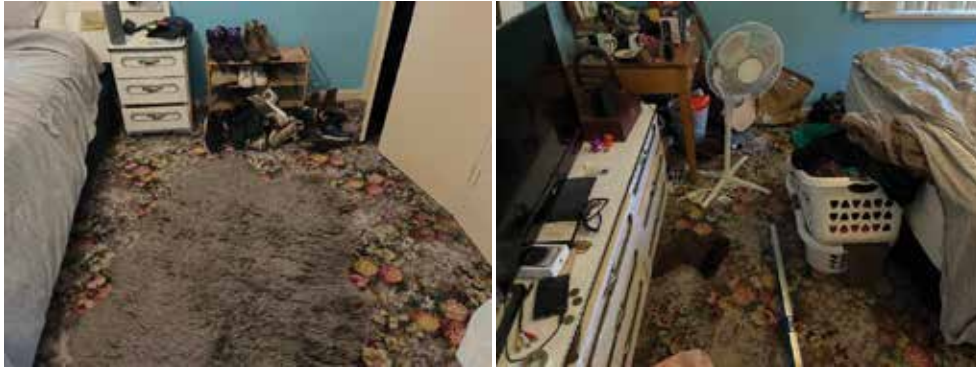
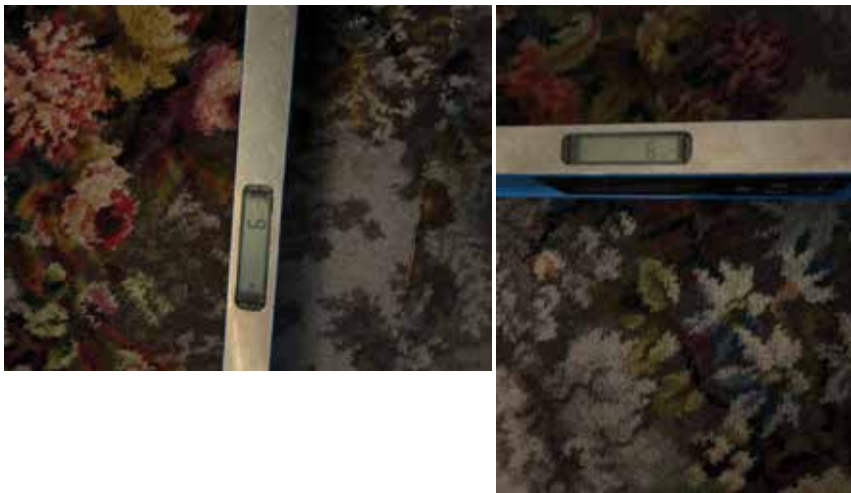
General age, deterioration or wear and tear to sections of the floor linings. General repair and maintenance advised.

Minor creaking in flooring sections - In some circumstances this can be due to workmanship, fixings loosened/ deteriorated, dampness/rain during construction. A qualified carpenter should be engaged to ascertain cause & remedy.

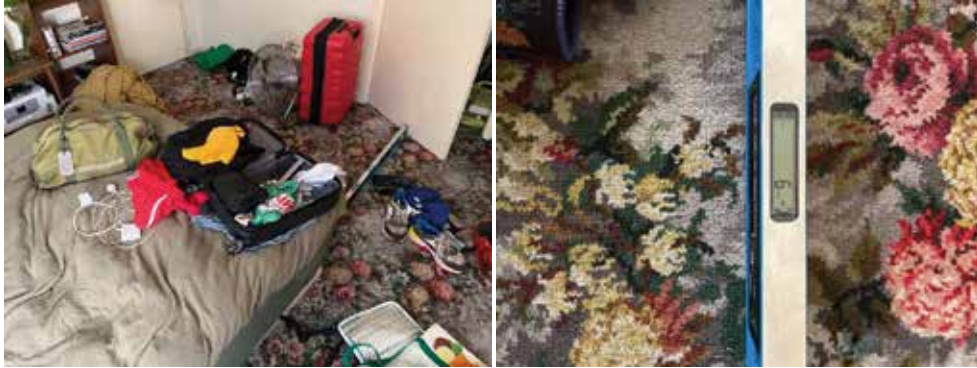
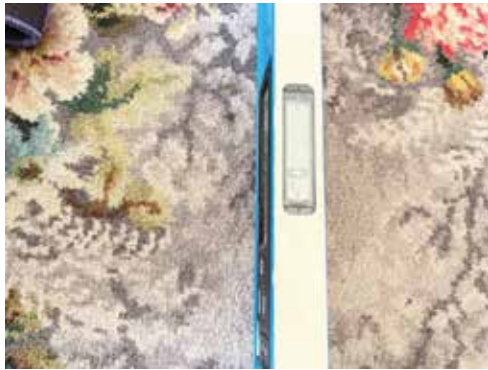
General age, deterioration or wear and tear to sections of the floor linings. General repair and maintenance advised.

Minor creaking in flooring sections - In some circumstances this can be due to workmanship, fixings loosened/deteriorated, dampness/rain during construction. A qualified carpenter should be engaged to ascertain cause & remedy.

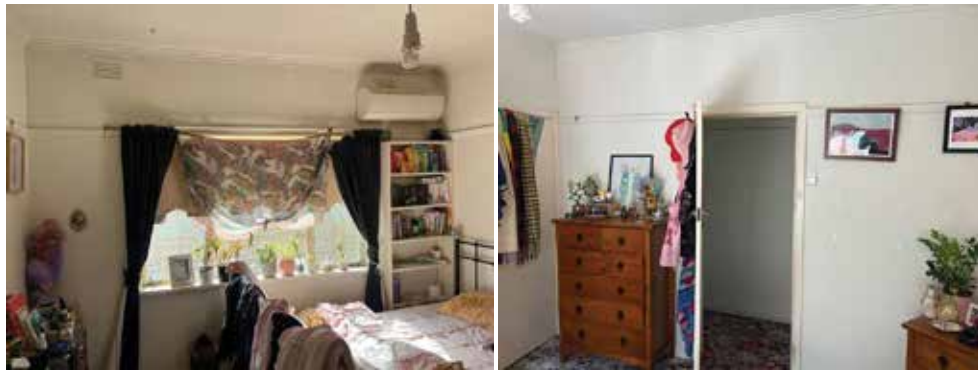
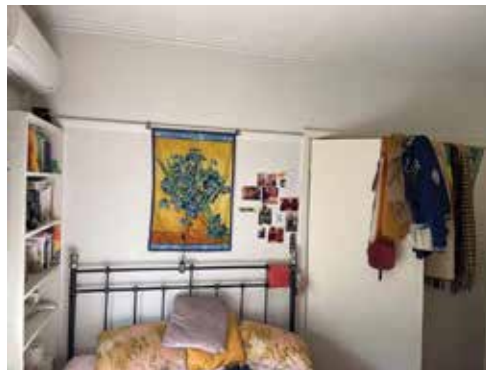
General age and/or wear and/or deterioration to door/components - General maintenance works required.

General ageing - this could be denting, paint deterioration, wear, previous patching, loose light fittings and the like on ceiling linings - A qualified tradesperson should be engaged to assess & repair as required.

Cornice cracks in ceiling areas - I recommend you contact a licensed plasterer for further advice & recommendations.

General ageing to Walls & Components - This can be denting, wear, paint deterioration, previous wall patching, damage/age to switches/points and the like - A relevant trades person should be engaged to assess & repair as required.

Settlement Cracks on wall areas. This can be related to differential settlement in footings, shrinkage in timber framing or poor plastering. Monitoring these cracks for 12 months is advised & if become wider or longer, you will need to contact a structural engineer to assess.

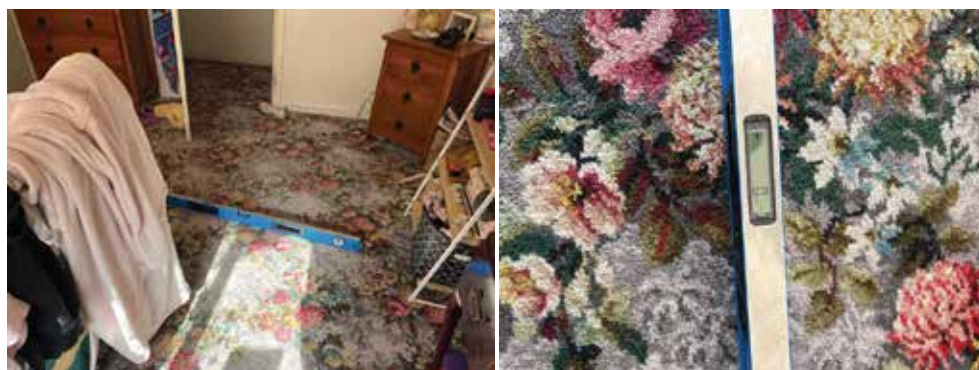
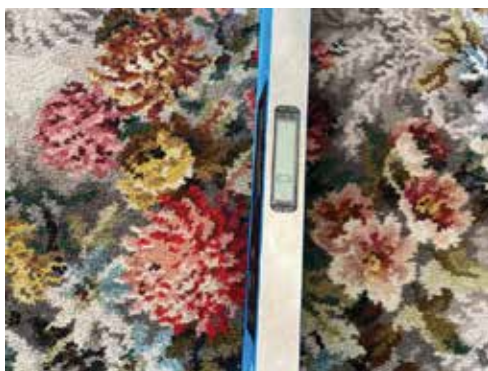
General age, deterioration or wear and tear to sections of the floor linings. General repair and maintenance advised.

Unevenness visible in sections of flooring - Possible causes - older homes have been re-stumped & not leveled adequately or could be some recent or past differential settlement in the footings. A qualified carpenter or stumping contractor should be engaged to assess immediately - homes levels & adjustments may be necessary.

Minor creaking in flooring sections - In some circumstances this can be due to workmanship, fixings loosened/deteriorated, dampness/rain during construction. A qualified carpenter should be engaged to ascertain cause & remedy.

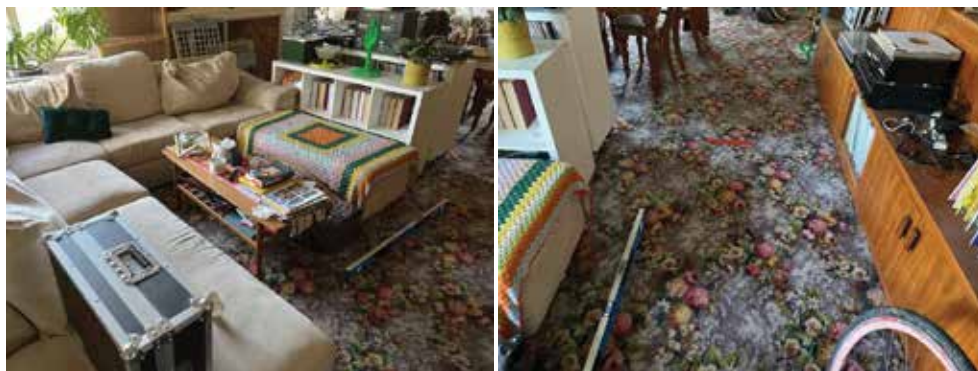
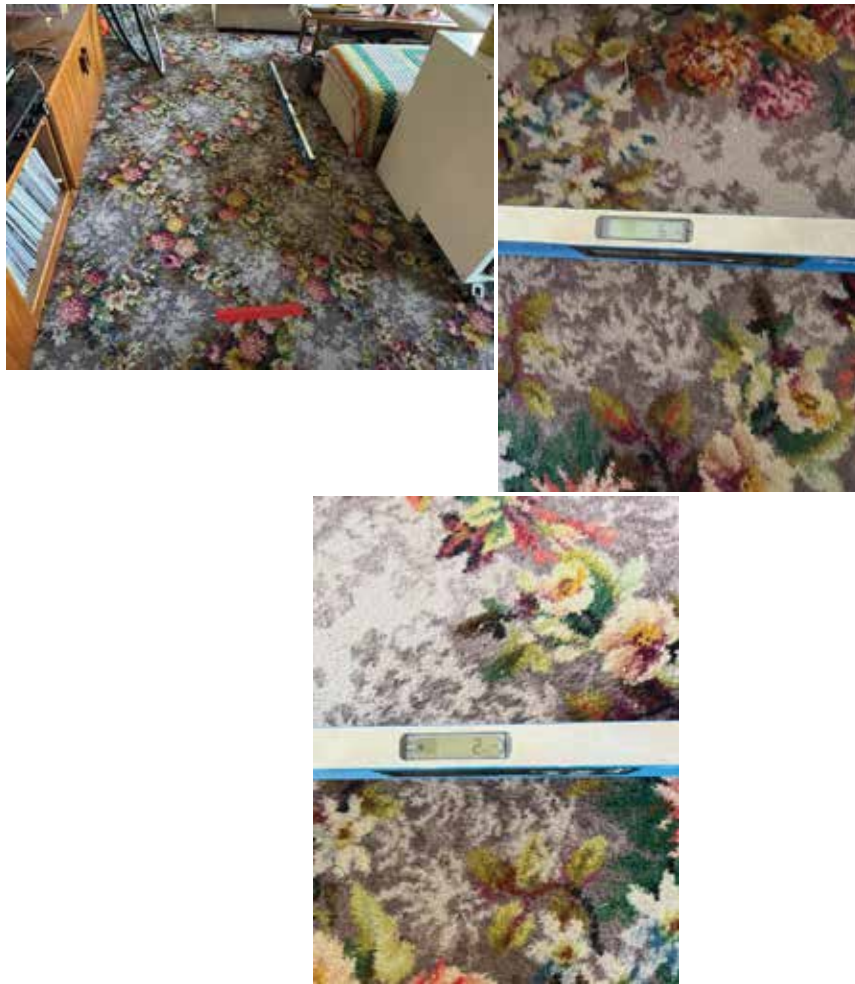
General age, deterioration or wear and tear to sections of the floor linings. General repair and maintenance advised.

Minor creaking in flooring sections - In some circumstances this can be due to workmanship, fixings loosened/deteriorated, dampness/rain during construction. A qualified carpenter should be engaged to ascertain cause & remedy.

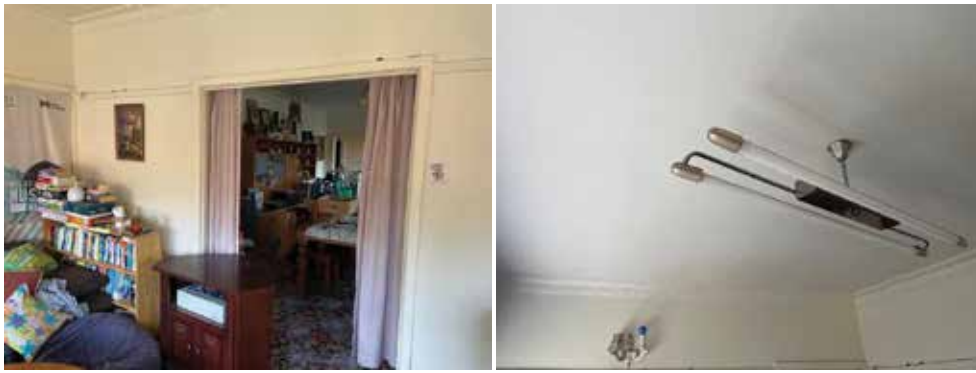
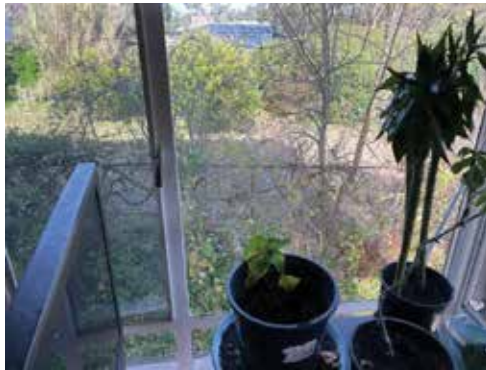
General age and/or wear and/or deterioration to door/components - General maintenance works required.

General ageing - this could be denting, paint deterioration, wear, previous patching, loose light fittings and the like on ceiling linings - A qualified tradesperson should be engaged to assess & repair as required.

General ageing to Walls & Components - This can be denting, wear, paint deterioration, previous wall patching, damage/age to switches/points and the like - A relevant trades person should be engaged to assess & repair as required.

General age/wear, paint deterioration or patching to window areas. General maintenance works required by carpenter and/or painter.
