# Inspection Report

**Safehome PTY LTD**

**1 Smith St, Pennydale, VIC, 3192**

Report/Agreement #	2305230921506
Inspection Date:	23 May 2023
Inspection Time:	11:00 am

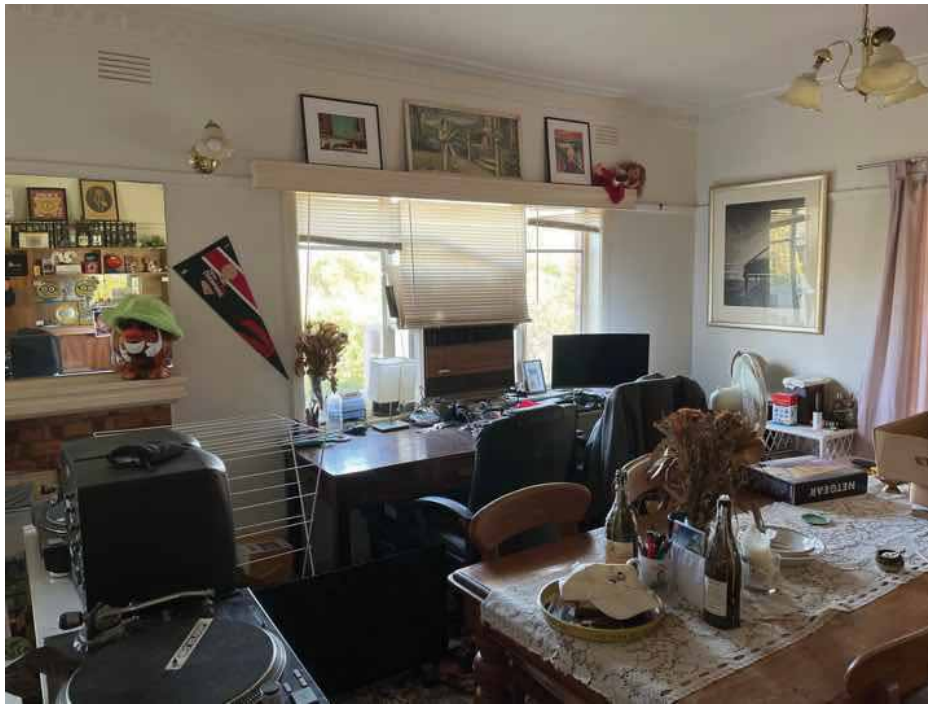
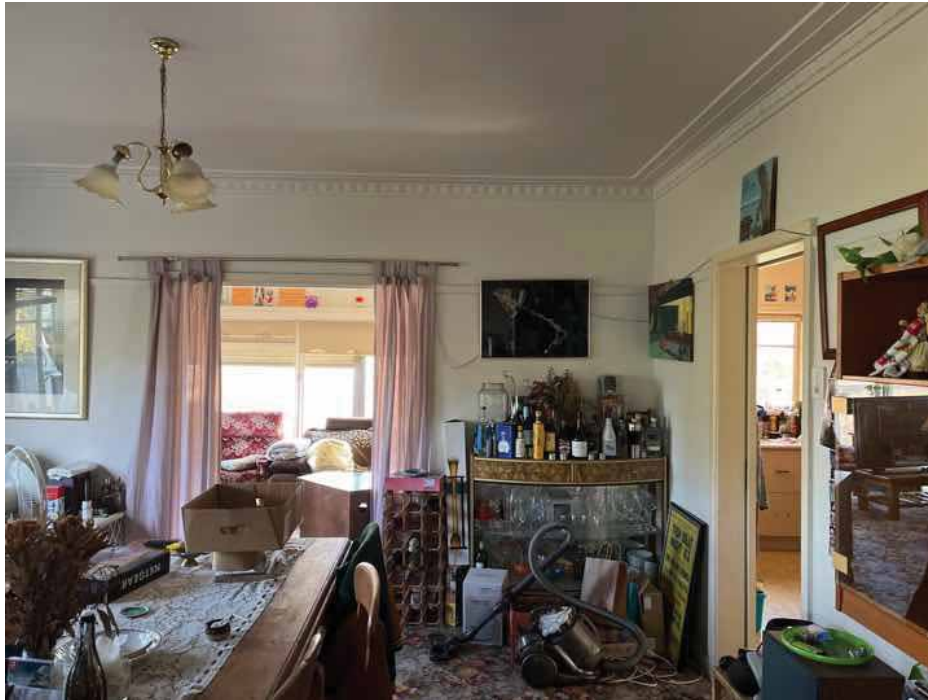
General age and/or wear and/or deterioration to door/components - General maintenance works required.

General ageing - this could be denting, paint deterioration, wear, previous patching, loose light fittings and the like on ceiling linings - A qualified tradesperson should be engaged to assess & repair as required.

General ageing to Walls & Components - This can be denting, wear, paint deterioration, previous wall patching, damage/age to switches/points and the like - A relevant trades person should be engaged to assess & repair as required.

General age/wear, paint deterioration or patching to window areas. General maintenance works required by carpenter and/or painter.

Cracked glass pane - A glazier should be engaged as soon as possible to replace as this is a potential safety hazard.

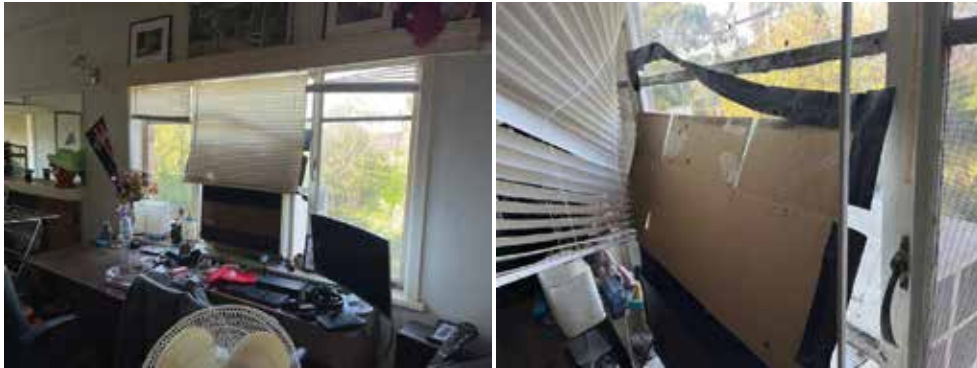
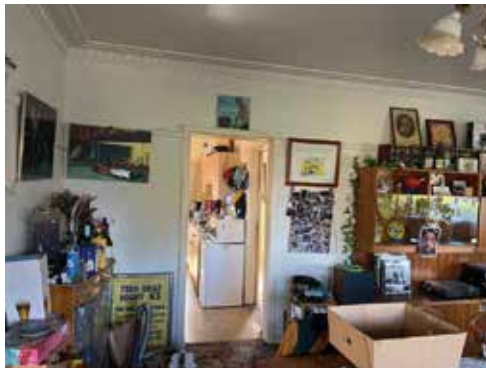
General age, deterioration or wear and tear to sections of the floor linings. General repair and maintenance advised.

Unevenness visible in sections of flooring - Possible causes - older homes have been re-stumped & not leveled adequately or could be some recent or past differential settlement in the footings. A qualified carpenter or stumping contractor should be engaged to assess immediately - homes levels & adjustments may be necessary.

Minor creaking in flooring sections - In some circumstances this can be due to workmanship, fixings loosened/deteriorated, dampness/rain during construction. A qualified carpenter should be engaged to ascertain cause & remedy.

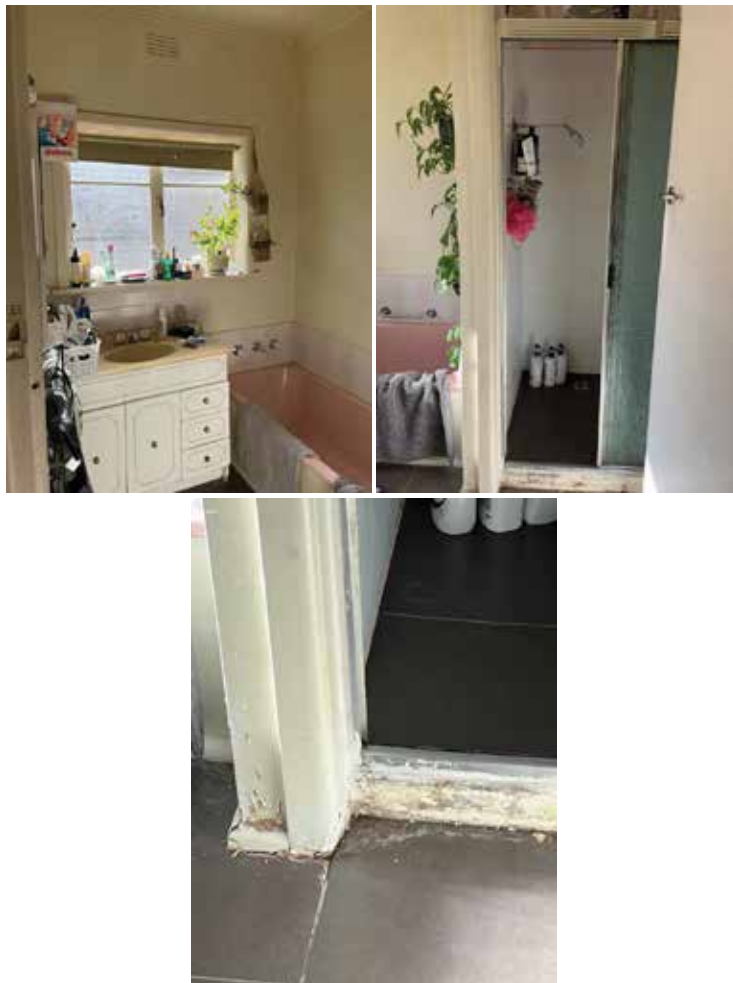
General age and/or wear and/or deterioration to door/components - General maintenance works required.

Appears current leak from shower recess into surrounding wall / skirting board areas. High moisture readings obtained in areas outside shower recess. Engage a plumber to assess and repair leaks. Potential timber bottom plate, stud and floor damage requiring assessing after plaster/linings removed.

Old damage to flooring. This is possibly been caused by past leaks from the shower recess. Have a carpenter assess and repair as required

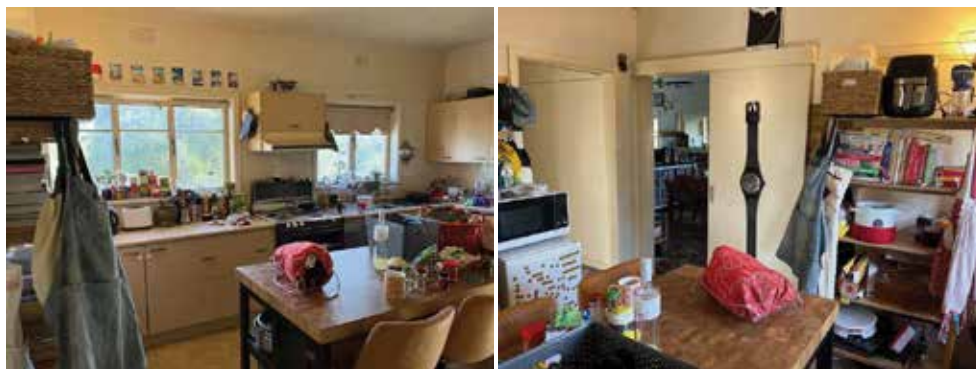
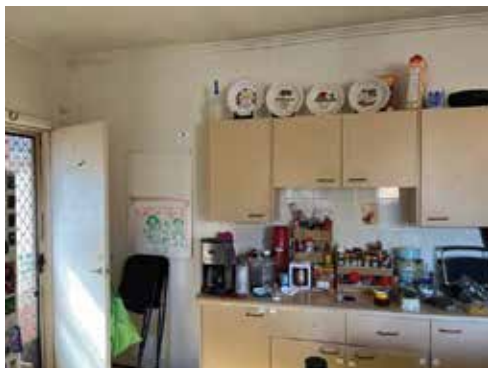
Bench top and splash back junction sealing deteriorated - Re-sealing by a plumber or general maintenance contractor is recommended to prevent water access behind the benches/vanity.

Damaged areas of oven. Have repaired

Mould in cupboard areas. Have professionally assessed and cleaned.

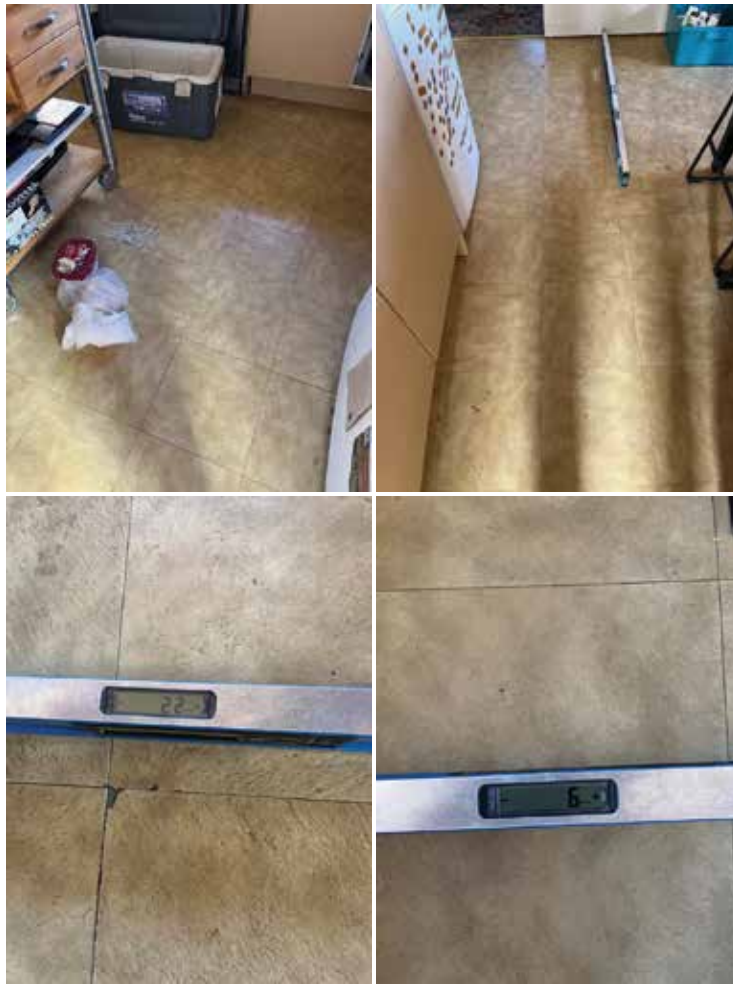
General age, deterioration or wear and tear to sections of the floor linings. General repair and maintenance advised.

Minor creaking in flooring sections - In some circumstances this can be due to workmanship and/or fixings loosened, deteriorated, dampness/rain during construction. A qualified carpenter should be engaged to ascertain cause & remedy.

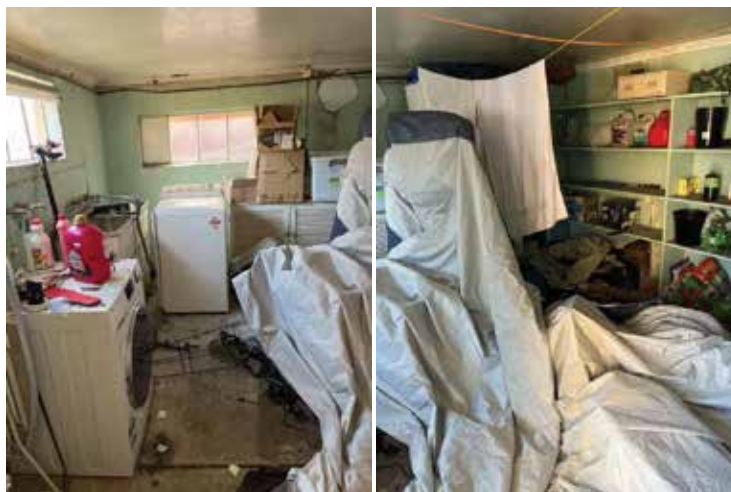
There maybe damage to timber wall frame behind this wall.

Old floor staining visible. Typically caused by past leaks.

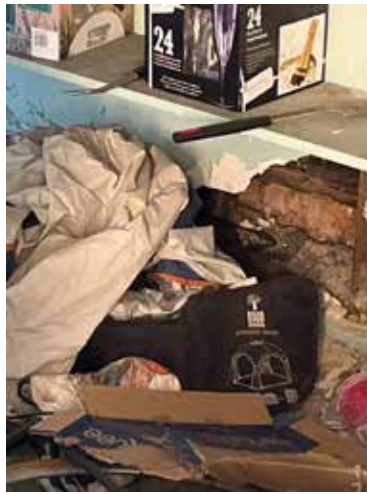
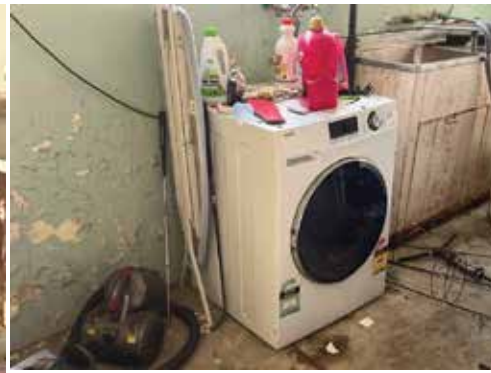
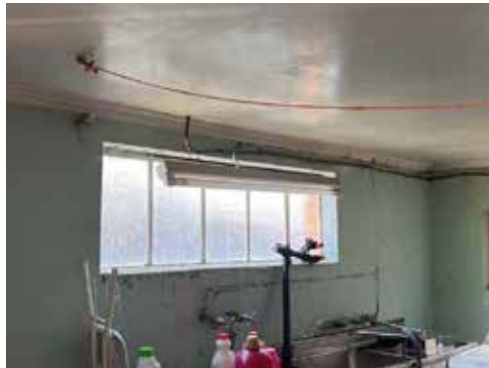
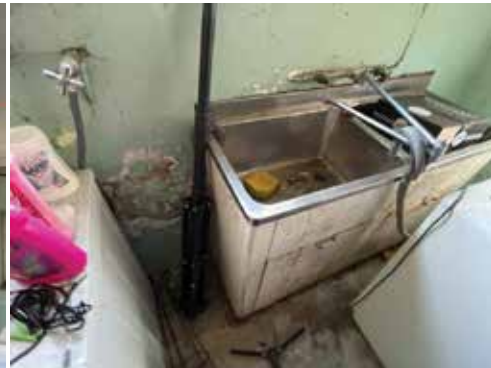
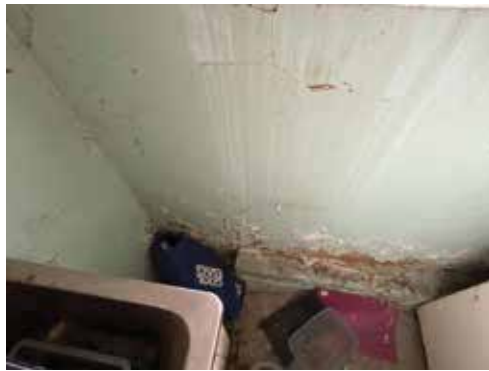
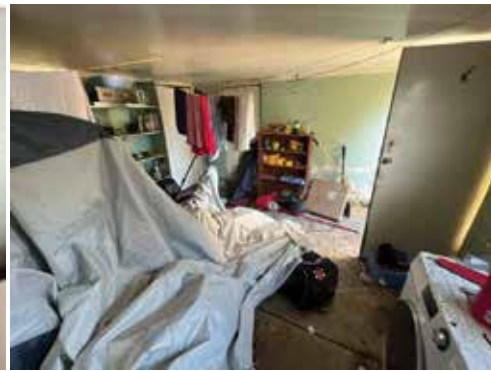
### Tub & Bench Top

Bench top and splash back junction sealing deteriorated - Re-sealing by a plumber or general maintenance contractor is recommended to prevent water access behind the benches/vanity.

General ageing & deterioration of the sink, cupboards and benches - Update kitchen as required.

Evidence of past leaks/damage to vanity areas - general repairs as required. Monitor for potential leaks in future.

Splash back grout age/deterioration - Engage a qualified tiler for advice & recommendations re sealing.

Bench top/frame/cabinet decay from water penetration - Engage a qualified cabinet maker for advice & recommendations.

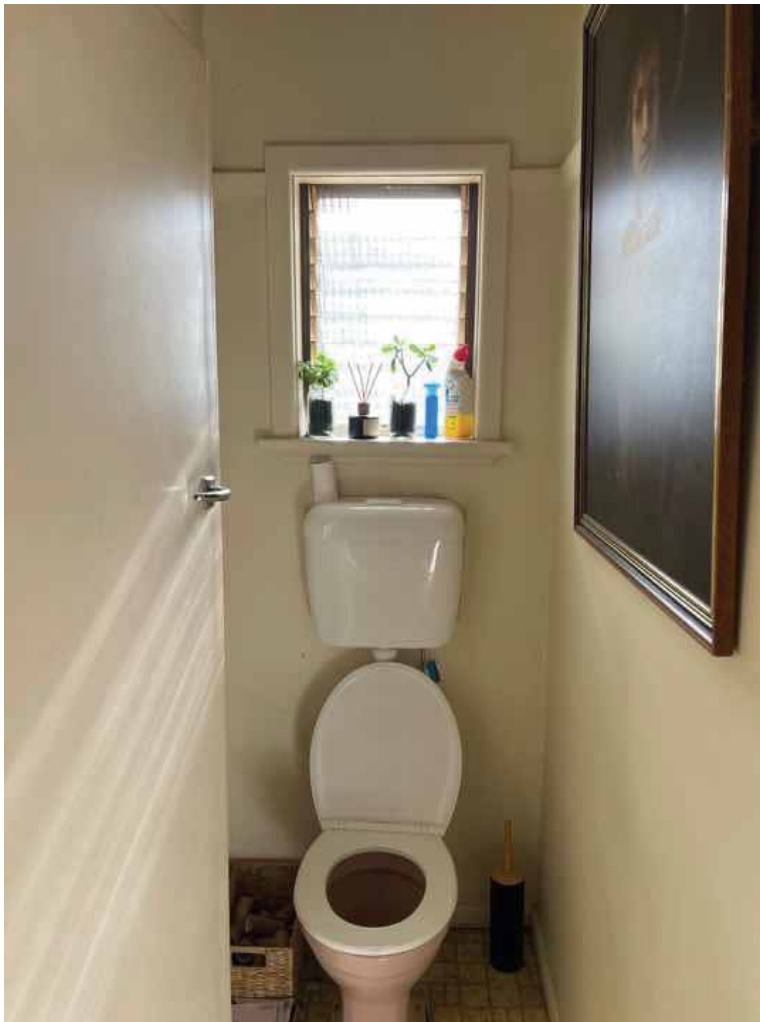
**Door Opening**

The door was found to be in acceptable condition for the age of this dwelling.

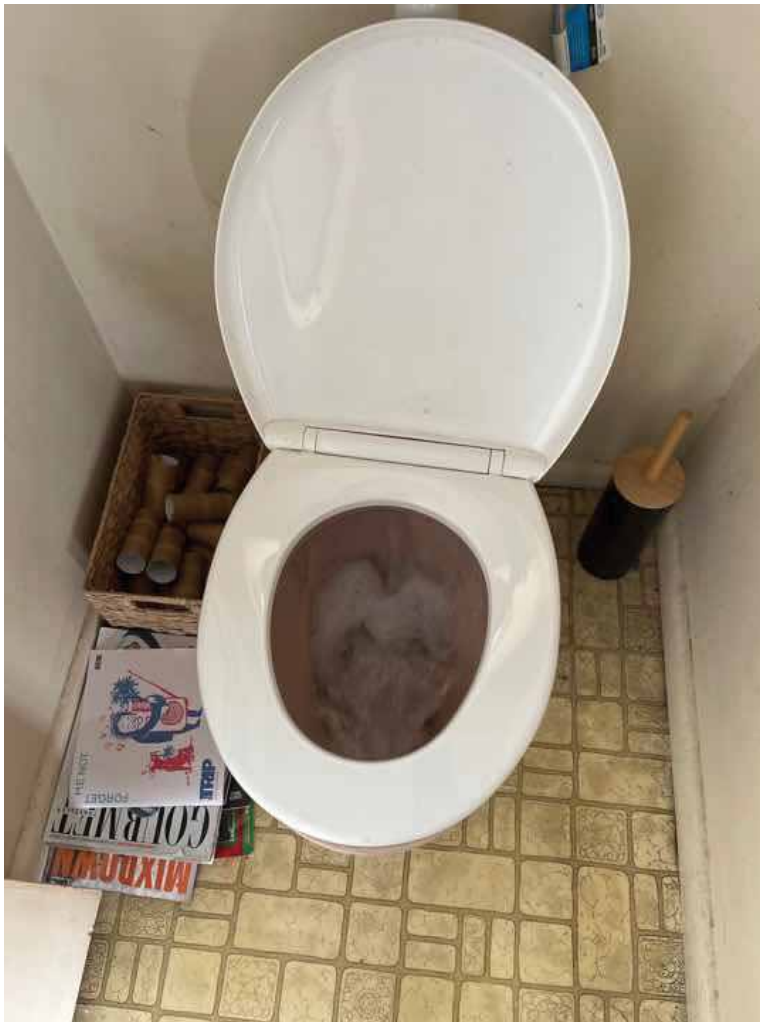
### Toilet

General Ageing, wear, damage or deterioration of the toilet & components. Updating should be considered.

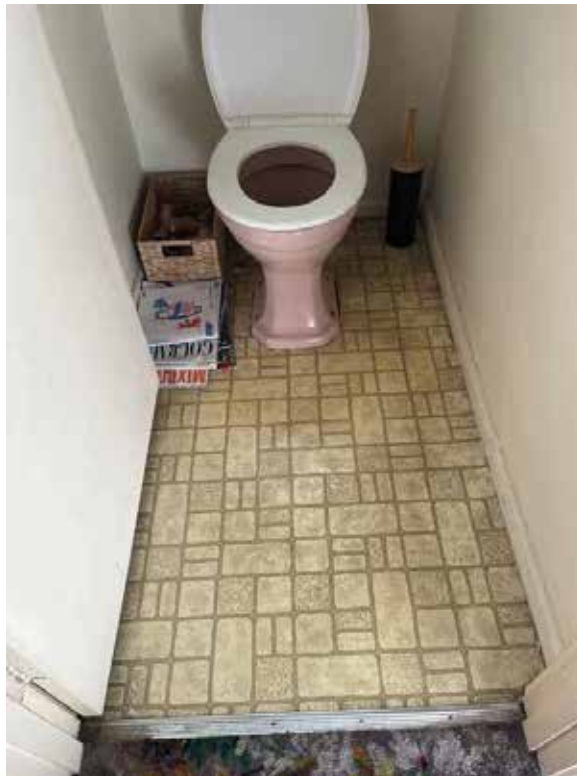
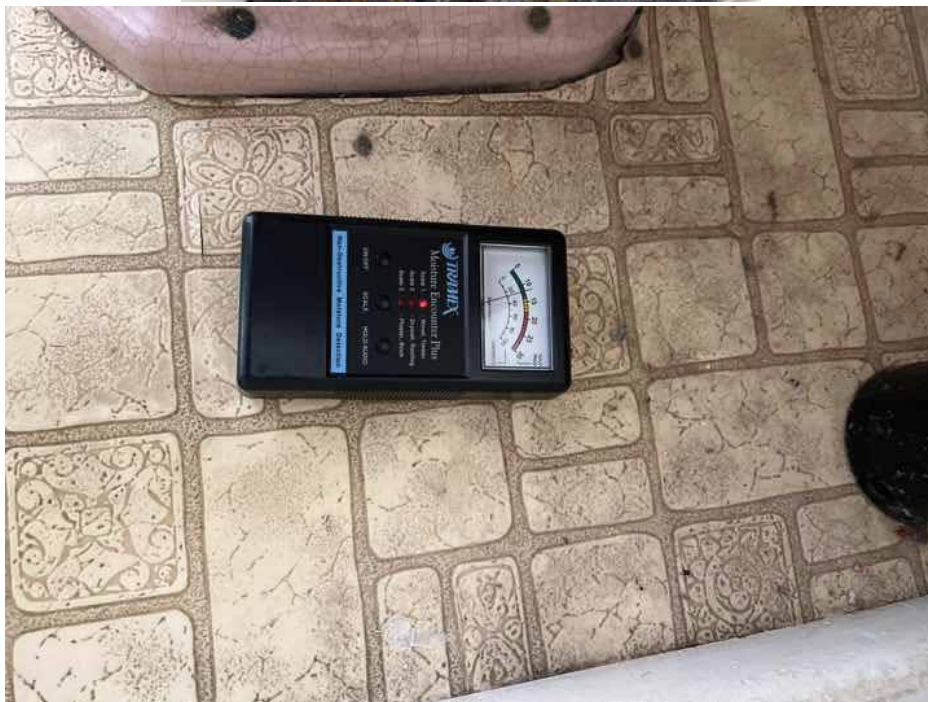
## Flooring

General age, deterioration or wear and tear to sections of the floor linings. General repair and maintenance advised.

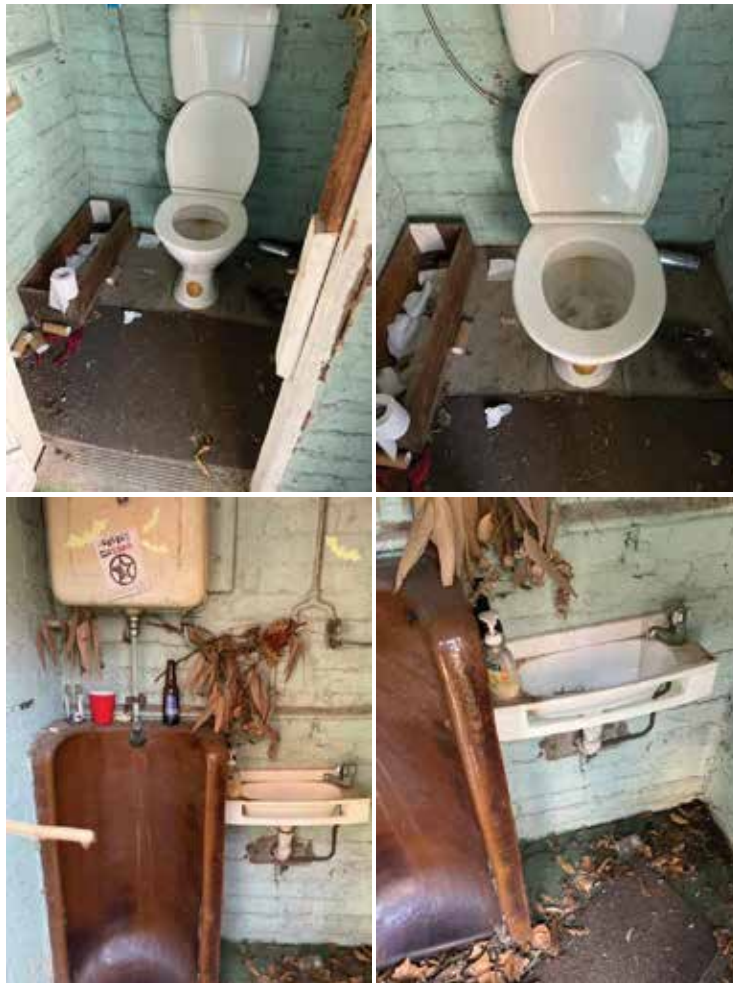
### Toilet

General Ageing, wear, damage or deterioration of the toilet & components. Updating should be considered.

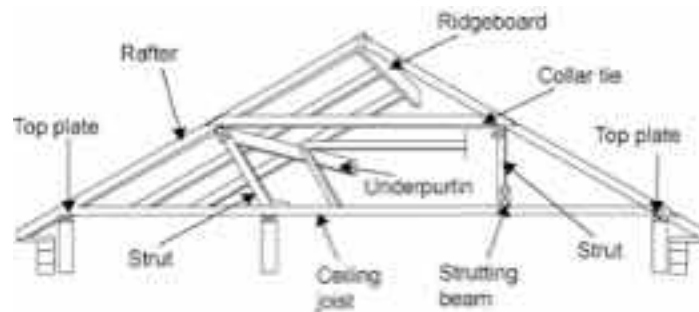
## Roof Frame Findings

No full access could be made to thoroughly inspect

The strutting of the roofing is considered inadequate/poorly fixed - Engage a qualified Carpenter to assess.

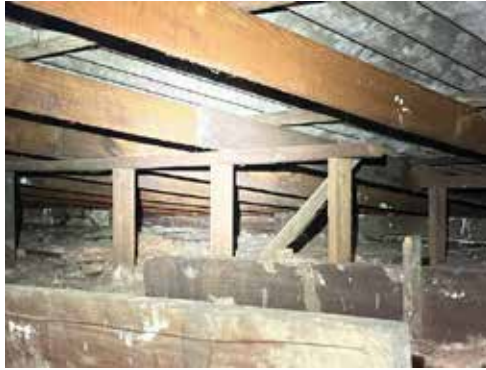
### **Roof Cladding Findings**

No full access could be made to thoroughly inspect

General ageing/deterioration/debris build up. Consider replacement.

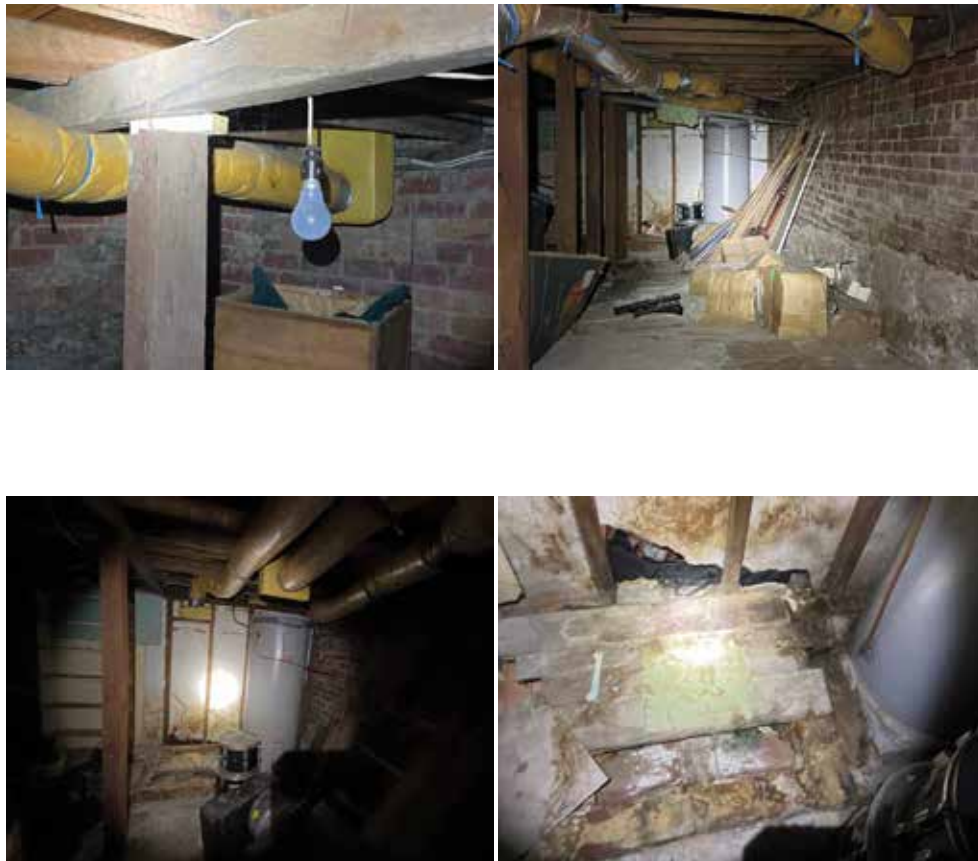
### **Sub Floor Door**

General age and/or wear and/or deterioration and/or minor unevenness to door/components - General maintenance works required.

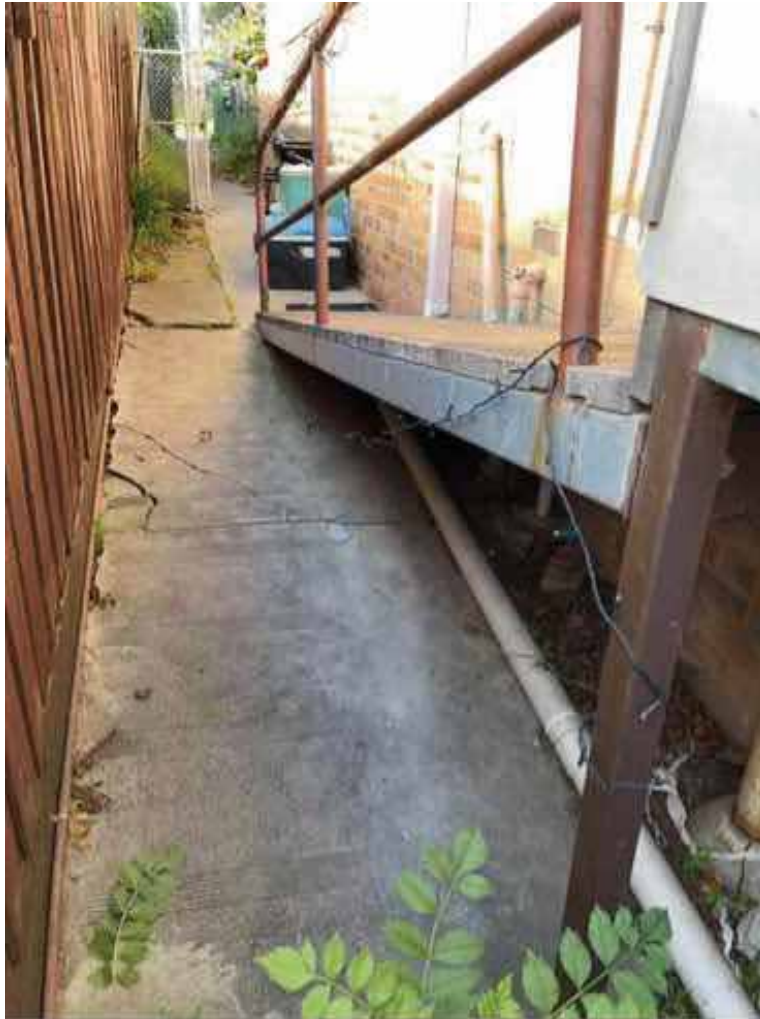
#### **Frame**

General ageing & deterioration - Engage a qualified carpenter to assess/repair as required.
